Study of collapse occured during the reinforcement work of a vault in a chalk quarry located in the north of Paris (France)

Study of a collapse occurred during the reinforcement work of a vault in a chalk quarry located in the north of Paris (France).

ABSTRACT: A vault of around ten tons weight collapsed unexpectedly during the reinforcement operations carried out in an old underground chalk quarry, which causes a serious accident. This paper describes the accident circumstances, gives some explanations for the accident, and present a simple 3 dimensional model realized to study the stability of the vault taking into account influence of local discontinuities.

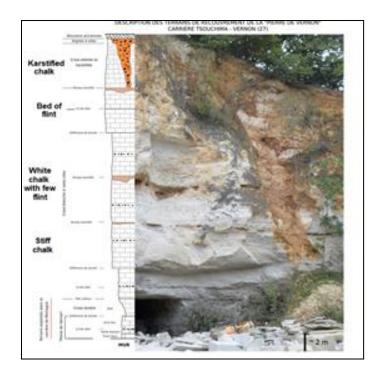
Figure 1. Overburden geology over the quarry (mainly chalked layers).

On the upper part of the roof of the quarry, the Coniacian-Santonian chalk would be covered with old alluvium from the Seine (very high alluvium, dated Pliocene), characterized by plates of blunted pebbles, sometimes a few meters thick. A representative geological profile of quarry roof is visible from about 400 m (Fig. 1).

The alteration of chalk, especially development of a karstification in the covering, are quite visible on this natural profile. Indeed, the studied site is characterized by the presence of deep alteration roots in the cover, some of which have been intercepted by the mining galleries located at about 45 m depth. This geological singularity is not without consequences on the stability of the quarry, since these roots sometimes drain naturally flint clays, leading to the formation on the surface of craters of large diameters (~ 10 to 12 m) (Fig. 2).

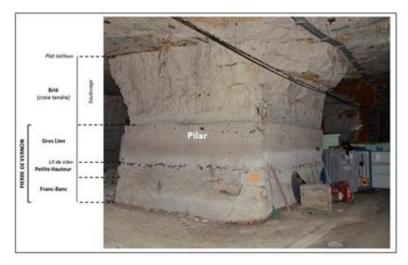
Figure 3. Local geology at a pillar scale

- The 'Franc-Banc', located at the base and excavated on about 90 cm thick;
- The 'Petite Hauteur' or 'small height', exploited about 40 to 60 cm thick, separated from the 'Franc-Banc' by the 'lit Franc' or 'bed Franc';
- The 'Gros lien', exploited about 60 cm thick, separated from the two benches beneath by a bed of flint clearly visible in the quarry.

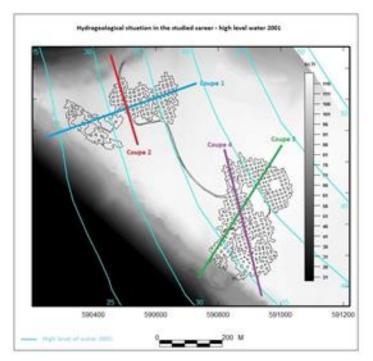
Figure 4. Hydrology situation on the quarry (data from BRGM/ SIGES-SN)

Chalk represent the main aquifer on the quarry. According to the geological atlas published by the BRGM in the studied area (Fig. 4), the altitude of the roof of the aquifer at the plateau level is between + 30 m and + 40 m NGF (for a medium water level). In other words, between 70 and 80 m depth in relation to the surface perpendicular to the quarry, and between 30 and 50 m deep compared to the level of the bottom of the quarry (overall between +72 m and + 82 m NGF.

This precludes the possibility of a flood of the underground quarry by an increase level of water table.

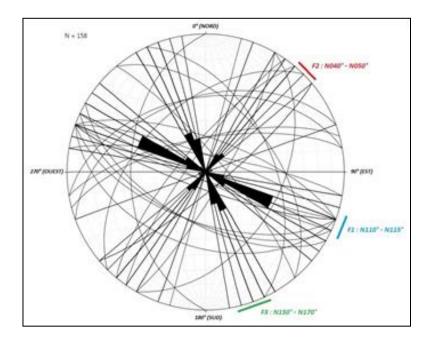
Figure 5. Projection on the Schmidt Diagram (south hemisphere) of the three family fractures observed in the chalk studied quarry.

The projection on a Schmidt diagrams (bottom hemisphere) of the 158 observed natural fractures (faults or diaclases), highlights three main orientations (three family) which are consistent with the regional ones (Fig. 5).

Note that the area of the accident is crossed by two diaclases belonging to the F1 family.

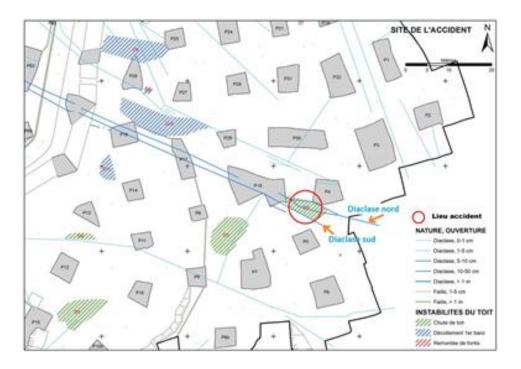
Figure 6. Situation of underground work near the collapsed zone.

The accident occurred in an area crossed by two subparallel discontinuities. The first limited the crash area to the north, The first limited the crash area to the north, splitting into two fractures on the collapsed zone, creating a first block that had broken off when drilling a dozen holes on the roof (Fig. 6). These latest were intended to receive the bolts that were going to fix the metal beam serving to support the roof. The second discontinuity is located further south of the previous one, about 1.5 m away. It stops a few meters (~ 5 m) from the firm edge, on a karst cavity closed in height, probably drained of its clay filling material, well before the accident.

The accident zone is located between the P4 and P18 pillars; the zone was weakened by the presence of the two previous discontinuities. The average depth of underground work above the collapsed area would be of the order of 45 m.

At first sight, the pillars remained intact after the collapse of the vault, and no sign of settlement or occurrence of mechanical fractures were observed on the pillars after the collapse. A block with a mass of about 10 tons, bounded by the two joints, detached from the roof (Fig. 6).

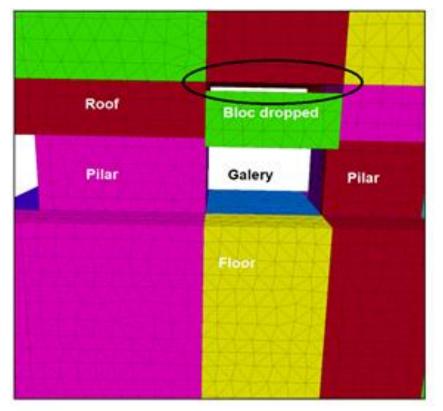
Figure 7. Simulation of the vault collapse induced by a decrease of cohesion and friction parameters.

We made a simple tridimensional geometry for the model representing the local collapsed zone with the real mean local dimensions of pillars and galleries. In the same time, we simplify the shape of the pillars (see Fig. 7).

As shown in these two Figures, the reduction of the mechanical properties (cohesion and angle of friction) of the two discontinuities inevitably leads to the rupture of the vault. We can see that the bloc dropped from the roof when the weight overcome the cohesion.
