Study of collapse occured during the reinforcement work of a vault in a chalk quarry located in the north of Paris (France)

Ahmed Hosni, Baptiste Meire, Gildas Noury, Didier Pennequin

ABSTRACT: A vault of around ten tons weight collapsed unexpectedly during the reinforcement operations carried out in an old underground chalk quarry, which causes a serious accident. This paper describes the accident circumstances, gives some explanations for the accident, and present a simple 3 dimensional model realized to study the stability of the vault taking into account influence of local discontinuities.

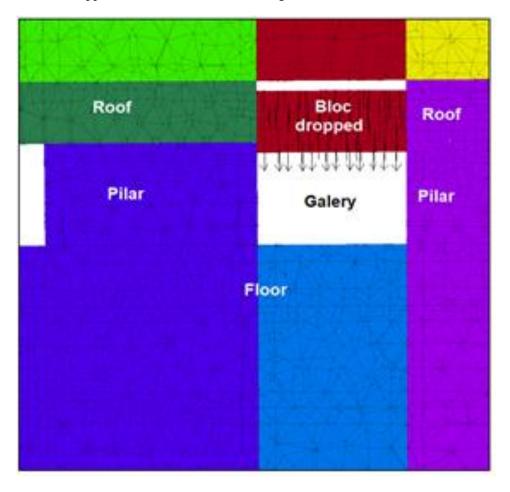
As shown in these two Figures, the reduction of the mechanical properties (cohesion and angle of friction) of the two discontinuities inevitably leads to the rupture of the vault. We can see that the bloc dropped from the roof when the weight overcome the cohesion.

Figure 8. Simulation of the vault collapse induced by a decrease of cohesion and friction parameters (vertical cross section).
