Study of collapse occurred during the reinforcement work of a vault in a chalk quarry located in the north of Paris (France)

Ahmed Hosni, Baptiste Meire, Gildas Noury, Didier Pennequin

ABSTRACT: A vault of around ten tons weight collapsed unexpectedly during the reinforcement operations carried out in an old underground chalk quarry, which causes a serious accident. This paper describes the accident circumstances, gives some explanations for the accident, and present a simple 3 dimensional model realized to study the stability of the vault taking into account influence of local discontinuities.

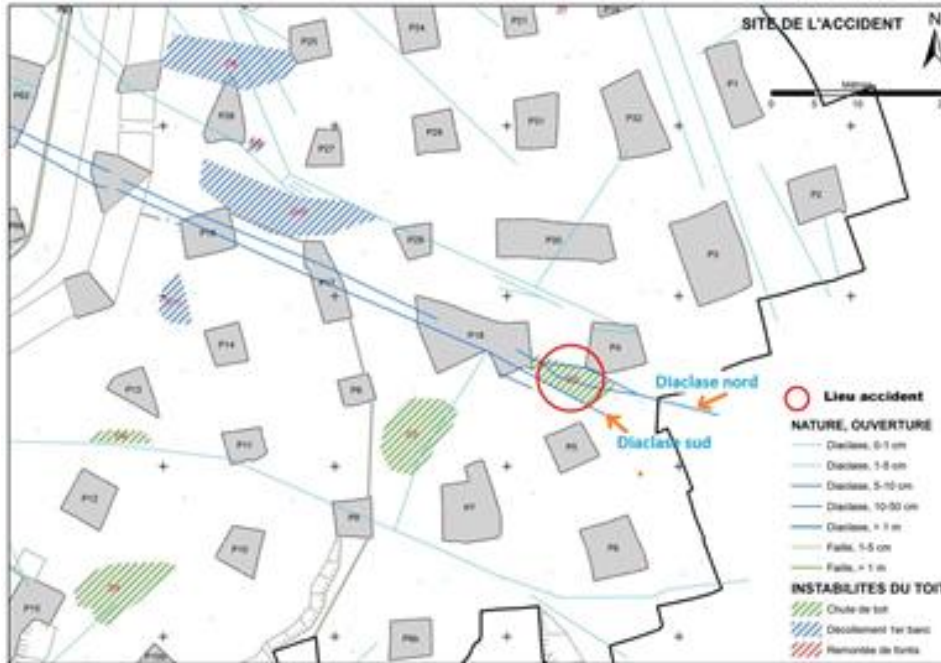
The accident occurred in an area crossed by two subparallel discontinuities. The first limited the crash area to the north, The first limited the crash area to the north, splitting into two fractures on the collapsed zone, creating a first block that had broken off when drilling a dozen holes on the roof (Fig. 6). These latest were intended to receive the bolts that were going to fix the metal beam serving to support the roof. The second discontinuity is located further south of the previous one, about 1.5 m away. It stops a few meters (~5 m) from the firm edge, on a karst cavity closed in height, probably drained of its clay filling material, well before the accident.

The accident zone is located between the P4 and P18 pillars; the zone was weakened by the presence of the two previous discontinuities. The average depth of underground work above the collapsed area would be of the order of 45 m.

At first sight, the pillars remained intact after the collapse of the vault, and no sign of settlement or occurrence of mechanical fractures were observed on the pillars after the collapse. A block with a mass of about 10 tons, bounded by the two joints, detached from the roof (Fig. 6).

Figure 6. Situation of underground work near the collapsed zone.
