# How Can the Morphometric Characteristics and Failure Conditions of a Historic Gully Caused by Intense Rainfall Be Reconstructed?

Claire Rault, Yannick Thiery, Bertrand Aunay, Bastien Colas, Kahina Reboul, et al.. How Can the Morphometric Characteristics and Failure Conditions of a Historic Gully Caused by Intense Rainfall Be Reconstructed?. *Earth*, 2022, 3 (1), pp.324-344. 10.3390/earth3010020 . hal-03683841

**Abstract:** In January 1980, during exceptional cyclonic rainfall, an atypical landslide, called *déboulé*, rapidly generated the permanent 700 m-long gully of the Ravine de l'Eglise on an inhabited plateau in Reunion Island (Indian Ocean). Retrieving the initial conditions that led to this historical process is both challenging and necessary for understanding the mechanism of gully incision and providing pointers for improving risk mitigation in relation to this phenomenon. In this study, we reconstruct the pre- and post-failure topographies using SFM (structure from motion) applied on archive aerial photographs. Based on the comparison of these digital elevation models, we estimate the volume of material eroded to be ca. 0.63 Mm<sup>3</sup>. Groundwater level increase,

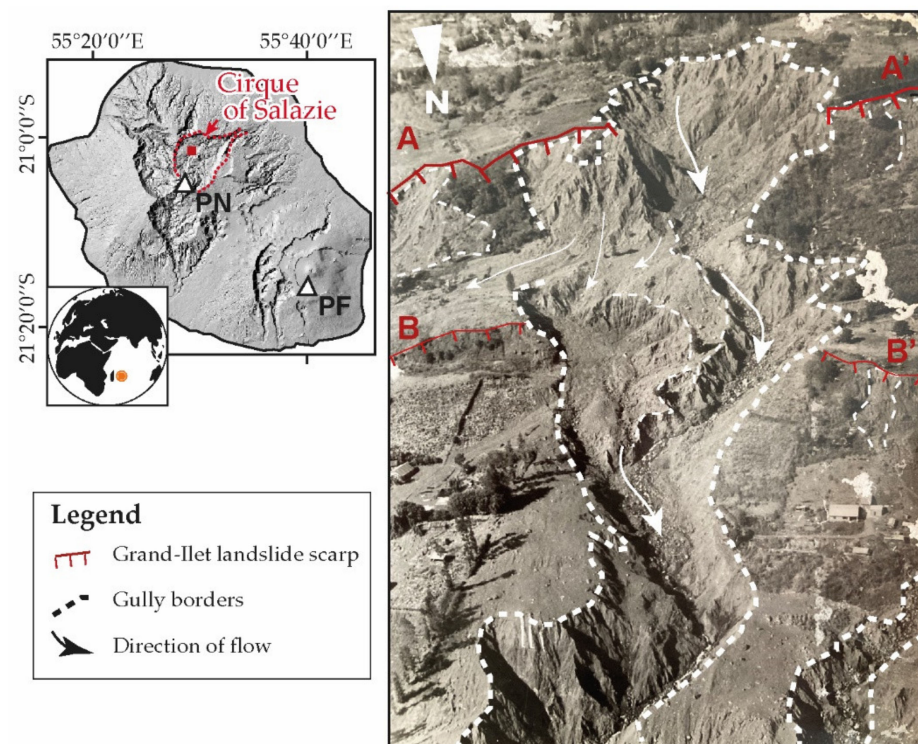
**Figure 1.** Photograph, modified from Pinchinot (1984) [8], of the *déboulé* of the Ravine de l'Eglise taken just after Cyclone Hyacinthe. The photo was taken in the field, at a date that is not exactly known. Grand Ilet is located by the red square in the image of Reunion Island to the left. PN, Piton des Neiges; PF, Piton de la Fournaise. Houses on the left side of the picture give the scale. AA' and BB' are scarps of Grand-Ilet landslide.

- Scarp A-A':
  - Head of the gully: 150 m wide, 50 m deep, head scarp slope  $> 45^\circ$ .
  - Lithology: zeolitized basalt and hard layers, rust-coloured, heavily fractured.
  - Movement:
    - Initiation: possible failure of scarp A-A' due to high pore pressure;
    - Progression: saturated material probably flowed rapidly downslope to the Ravine Roche à Jacquot, digging the terrain over 10 m to 30 m deep.
  - Springs: possible outlets along scarp A-A' after the first collapse, which may have induced the thinning of the terrain.
- Scarp B-B':
  - Head of the gully: hidden by products of the destabilization of scarp A-A'.

- Initiation: possible failure of part of scarp B-B' due to high pore pressure;
- Progression: the material flowed downslope but stayed quite cohesive compared to the material from the failure of scarp A-A'.

The photo (Figure 1) shows that the resulting channel was covered by blocs of up to several meters in size, and finer materials. Water was still flowing when the picture was taken. Deposits from intersected flows suggest that several destabilization processes occurred during the rainy episode, in agreement with the description made by Pinchinot (1984) [8].

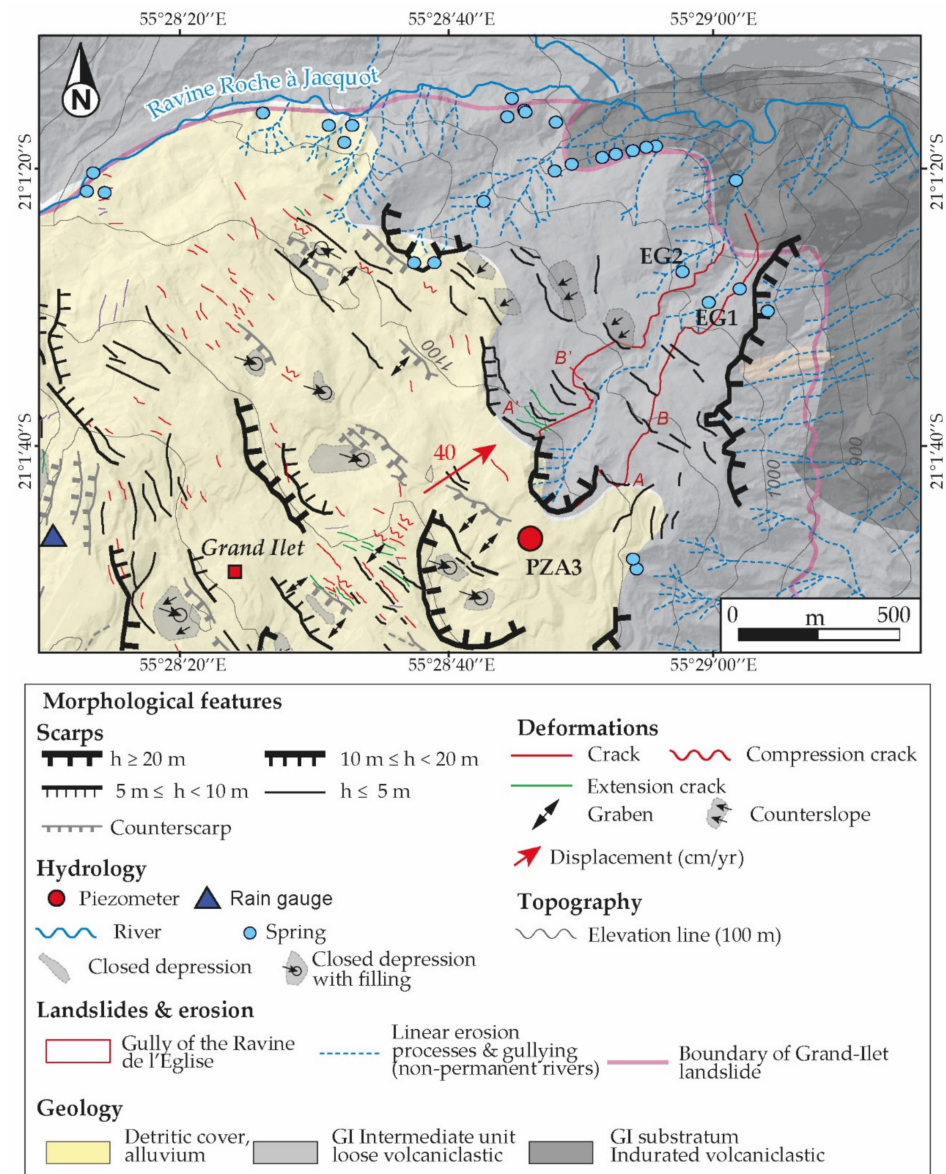
**Figure 2.** Geological and morphological settings of the gully of the Ravine de l'Eglise. EG1 and EG2: springs; PZA3: piezometer; GI: Grand Ilet. Figure adapted from Rault et al., in review [7].

The gully formed on the eastern part of the Grand Ilet landslide (Figure 2). This large compound landslide moves northeast slowly at about  $40$  to  $50 \text{ cm} \cdot \text{yr}^{-1}$  in the area of the Ravine de l'Eglise [7,46]. The mean slope of the Grand Ilet landslide is about  $10^\circ$ . Its surface is characterized by numerous features due to the landslide's movement (e.g., scarps, cracks,

No data concerning historic hydrological conditions was available for 1980 except the daily rainfall recorded at the Grand Ilet meteorological station located at ca. 1 km west of the head of the gully (Figure 2).

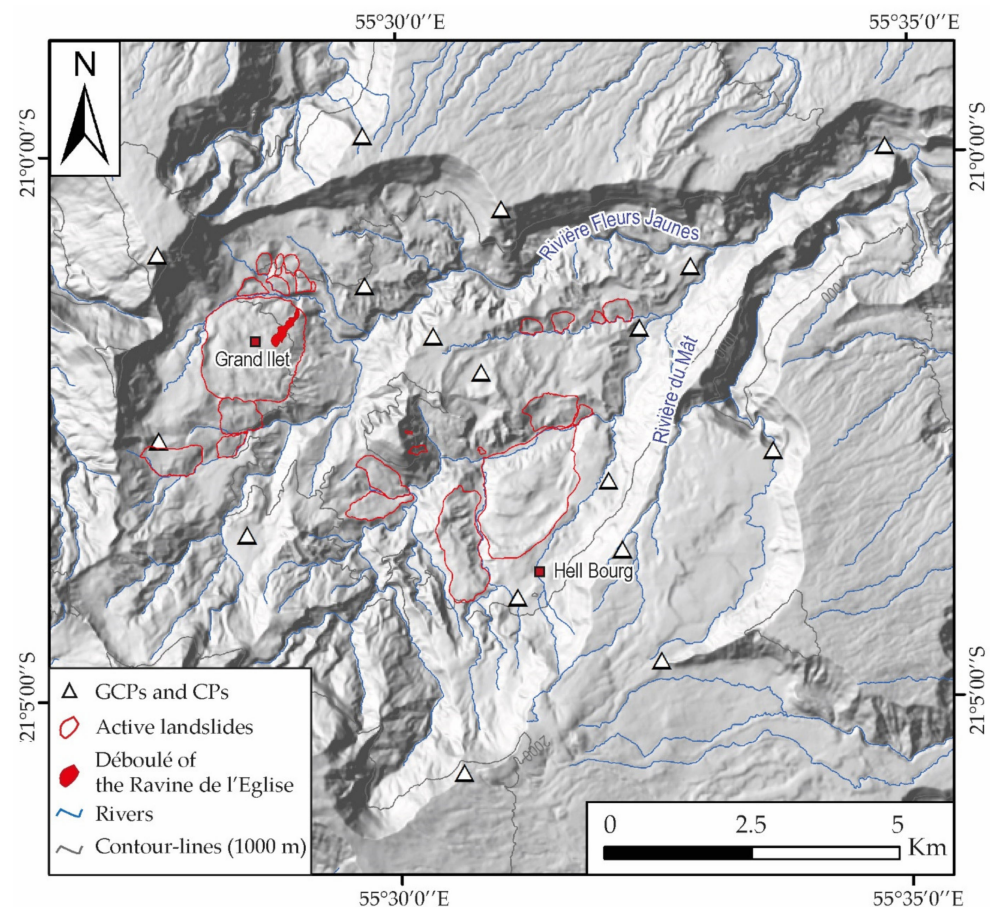
**Figure 3.** Localization of the control points used to build the 1978 and 1984 DSM and orthophotographs of the Cirque of Salazie. Most of the plateaus are occupied by active landslides [6,7,46]. GCPs: ground control points; CP: check points.

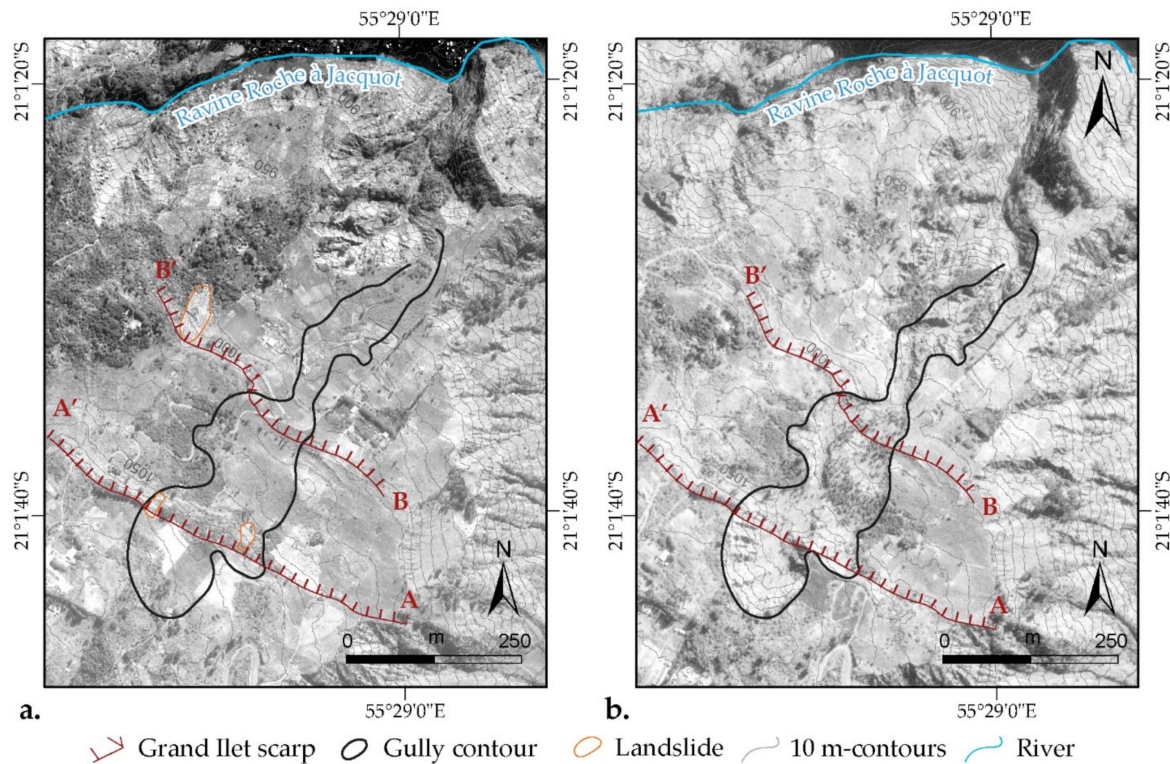
**Figure 4.** Morphological change following Cyclone Hyacinthe. (a). Orthophotograph and elevation lines of 1978. (b). Orthophotograph and elevation lines of 1984. The red lines A-A' and B-B' are the Grand Ilet scarps imaged in Figure 1. The orange polygons delineate small landslides identified on the aerial images of 1978.

Figure 4 shows the processed 0.6 m-resolution orthophotograph of 1978 and 1984 above the Ravine de l'Eglise, corresponding to the pre- and post-failure images of the surface respectively. These images are superimposed by elevation contours extracted from their respective 1 m-resolution DSMs.

In 1978, the surface was covered by agricultural fields with short vegetation. Scarps A-A' and B-B' were already active, as attested by small local landslides (Figure 4a). The elevation lines of the topography of 1978 reveal a small linear depression (ca. 5 m deep and 100 m wide), joining scarps B-B' and A-A' and ending in an active erosion area, where the *déboulé* occurred two years later (Figure S6). This depression is included in a small elongated watershed of about 0.067 km<sup>2</sup> and 744 m in length, with an average slope of 15°.

In 1984, the gully head has a badland morphology (Figure 4b). The vegetation has started to grow in some areas only, suggesting that the erosion must still have been active four years after the *déboulé*.

The maximum depth of the gully is observed at the toe of the scarps A-A'. Pre-failure and post-failure topographic profiles are presented in Figure 4c. The channel surface (topography of 1984 and 2015) is relatively smooth with a mean slope of 12°, similar to the initial topography (Figures 5c and S7). The gully has side walls from ca. 30 m to 10 m high, 30° steep (Figures 4b and S5).

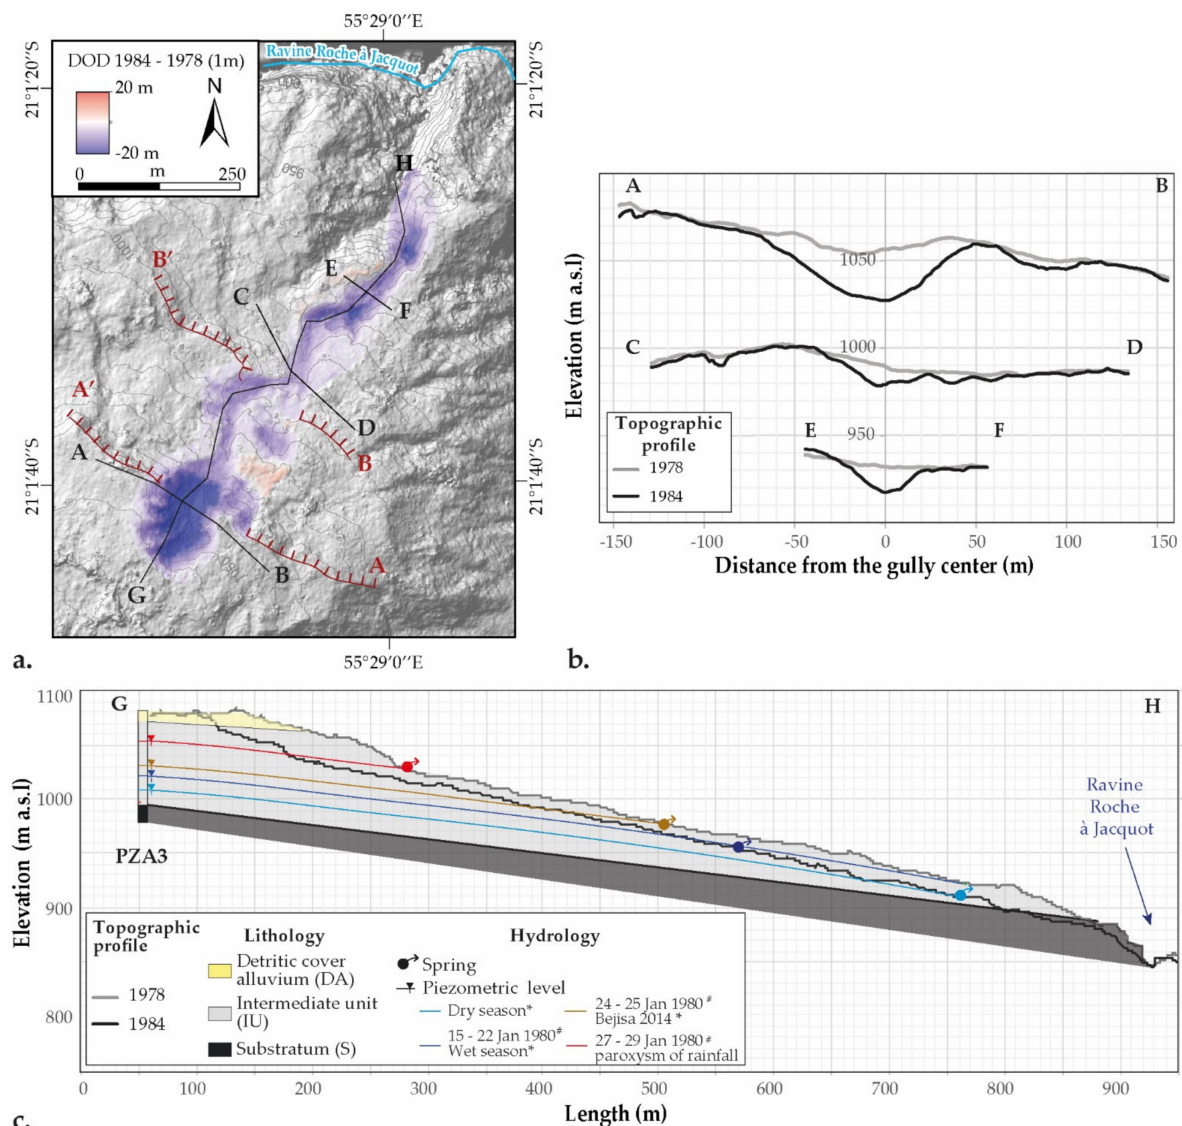
**Figure 5.** Comparison of the 1978 and 1984 topographies in the Ravine de l'Eglise watershed (a) 1 × 1 m DEM of Difference (DoD) comparing 1978 DSM and 1984 DSM calculated above the gully of the Ravine de l'Eglise. Deep blue indicates major surface excavation. The black lines A-B, C-D and E-F mark the ends of the transversal topographic profiles presented in (b) and G-F the longitudinal topographic profile presented in (c). The red lines A-A' and B-B' are the Grand Ilet scarps imaged in Figure 2. Light-grey lines are the 10 m elevation contours. (b) Transversal profiles of the gully. (c) Longitudinal profile of the gully with the measured and hindcast groundwater levels (see next section). #: piezometric level hindcast for Cyclone Hyacinthe, \*: piezometric level recorded.

The total negative difference (i.e., depletion) in the gully of the Ravine de l'Eglise is ca.  $6.3 \times 10^5 \pm 7.0 \times 10^4 \text{ m}^3$ . According to the picture of the *déboulé* taken just after it occurred (Figure 1), most of this material was rapidly evacuated downstream. The volume of material corresponds to the lower bound of the amount of material evacuated by the gully between 1978 and 1984, as the growth of vegetation and subsequent destabilizations may have induced the rise in elevation of the topography of 1984 in comparison to that of February 1980.

Reported on the pre-failure surface (Figure 5c), the maximum piezometric level of Cyclone Hyacinthe crosses the toe of the scarp A-A' that collapsed during Cyclone Hyacinthe. This is consistent with observations from inhabitants during the cyclone, who reported that sources emerged along A-A' after its collapse [6,7]. The hindcast water table north of scarp A-A' was above the ground surface. Such a groundwater level is thought to have led to an increase in pore water pressure and total stress in the whole terrain column between the surface and the less permeable substratum.

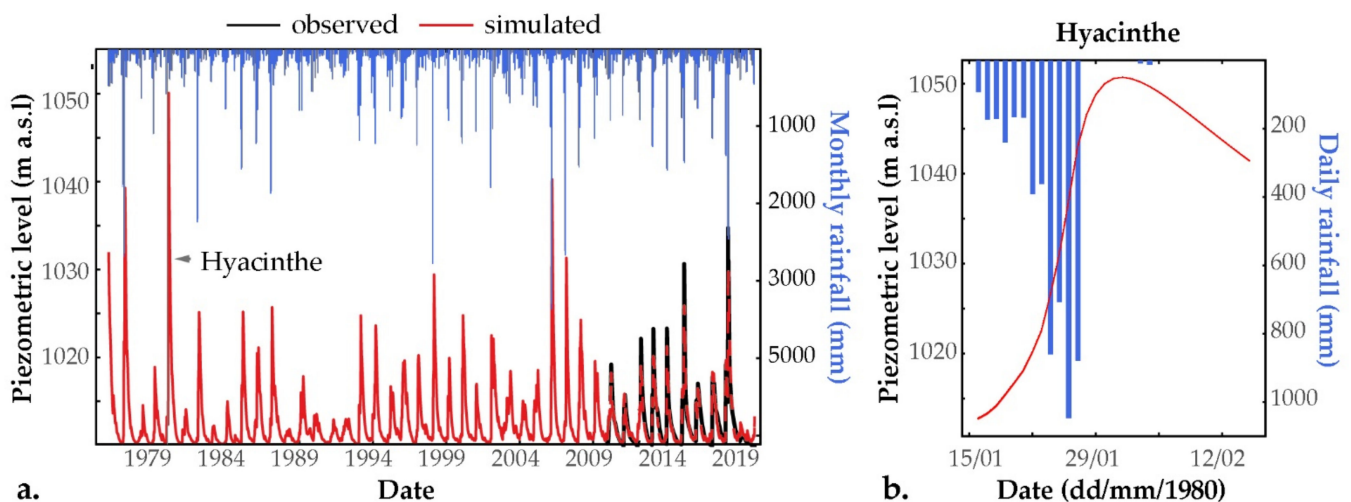
**Figure 6.** Rainfall recorded in Grand Ilet and piezometric level variation at PZA3 (see Figure 2) (a) from 1976 to 2020 and (b) during Cyclone Hyacinthe (15–27 January 1980). Blue bars are the rainfall; black and red lines are, respectively, the recorded and the hindcast water-levels since 1976. a.s.l. = above sea level.

Figure 6 shows the hindcast piezometric level of the Grand Ilet aquifer since 1978. The correlation of the measured and the modelled groundwater level from 2010 and 2020 with Gardenia® is clearly efficient, as attested by a Nash–Sutcliffe model efficiency coefficient (NSE) of 0.959. A model with an estimation error variance equal to zero has an NSE equal to 1 [64]. This good modelling allows the groundwater level to be hindcast at piezometer PZA3 from 1976 to 2010. The groundwater level just before Cyclone Hyacinthe was 1014 m above sea level (a.s.l.); i.e., in the average of those recorded during the rainy season in that piezometer. During Cyclone Hyacinthe, the water table rose progressively in response to the gradual increase in rainfall. The groundwater level may have reached at least 1050 m a.s.l., meaning an increase in groundwater of at least 36 m in only 13 days.

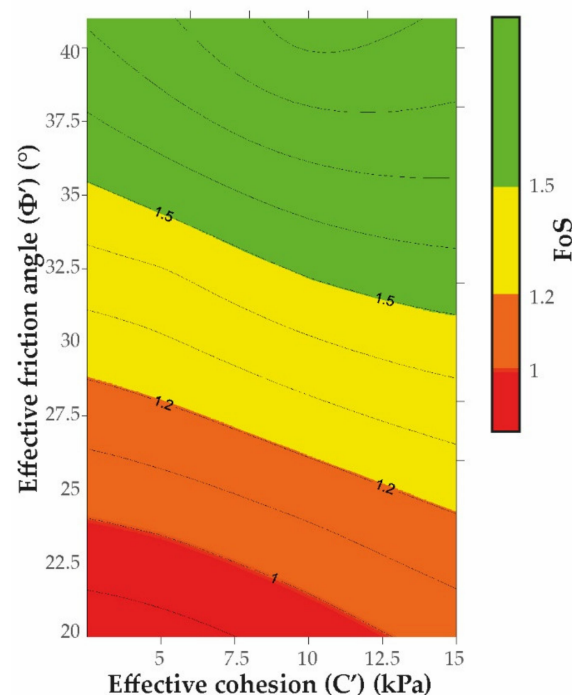
**Figure 7.** Sensitivity analysis of the intermediate unit. Slope instability along the topographic profile is obtained only at the toe of the slope under wet conditions when the  $C'$  effective cohesion and  $\Phi'$  effective friction angle have lower values. FoS: factor of safety.

Figure 7 shows the results of the sensitivity analysis under wet conditions. Under wet conditions, with a variation of  $\pm 50\%$  of  $C'$  around its average value (10 kPa), the FoS values vary by 12%. With the same conditions, by varying  $\Phi'$  by  $\pm 28\%$  around its average, the FoS values vary by about 60%.

Under wet conditions, the FoS is lower than 1 only if we consider the smaller known values of  $C'$  ( $\leq 5$  kPa) and  $\Phi'$  ( $\leq 23^\circ$ ) for the intermediate unit. Table 3 gives the parameters selected for simulation of the gully incision. Considering these parameters, scarp A-A' is at the limit of stability (FoS = 1) and the toe of the slope is unstable (FoS = 0.98) (Figure 8). This result is in agreement with the instability deformations (e.g., cracks, leaning trees) observed in the field along scarp A-A' and at the front of the Ravine de l'Eglise watershed before the gully incision.

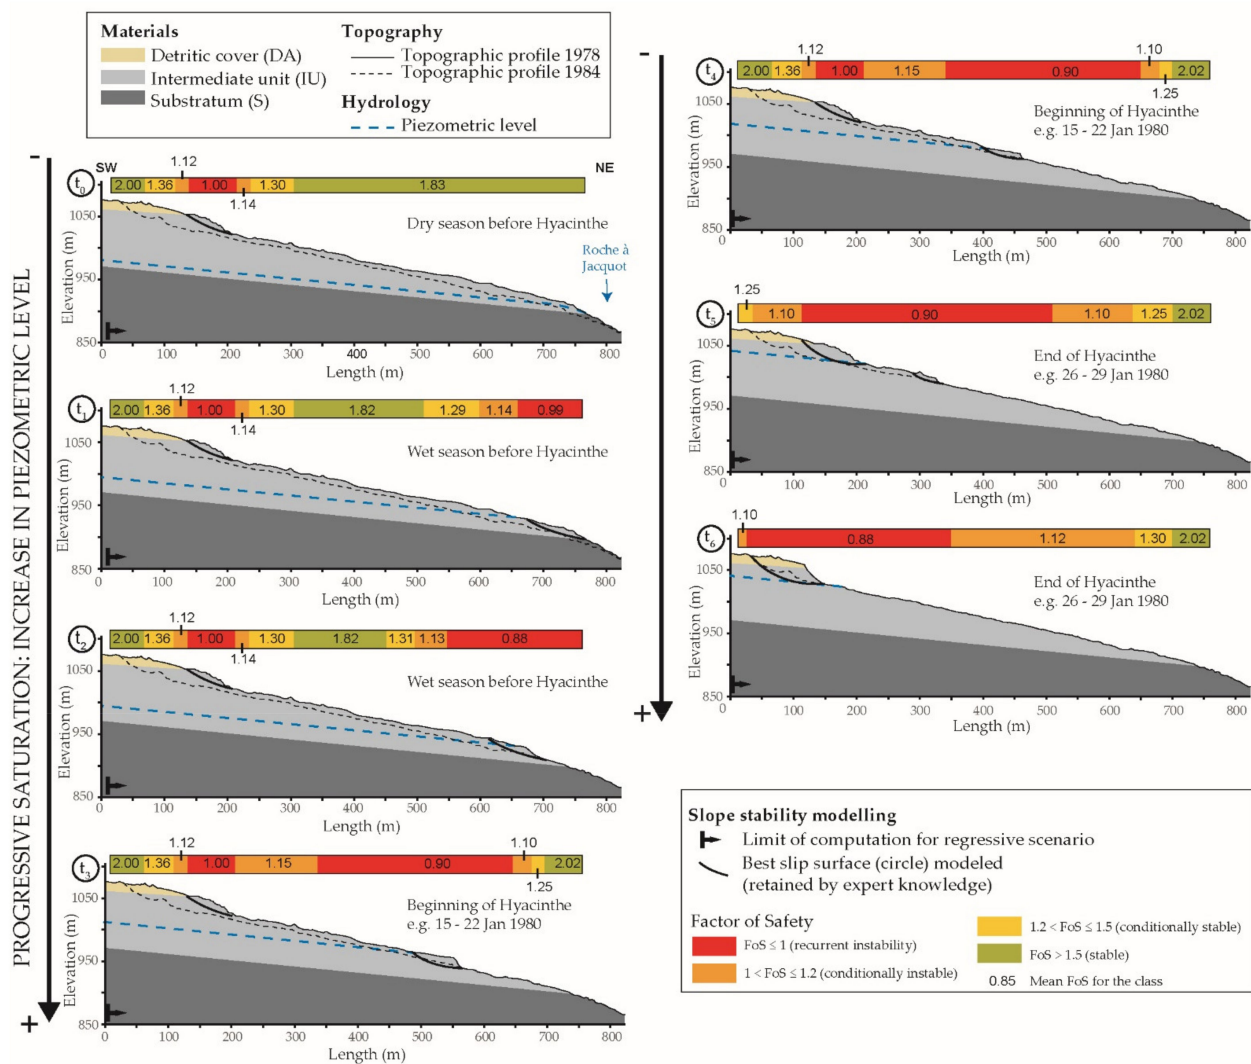
**Figure 8.** Headward retreat simulations. Scenarios  $t_0$  to  $t_6$  show the impact of the rise in groundwater level on slope stability (see text for more explanations). The mean values of FoS in the area delineated by coloured rectangles are given. Under dry conditions, the slope is stable except along the upper scarp. By increasing the groundwater level, successive retrogressive failures occur up to the current head of the gully. The values of geotechnical parameters used are in Table 3.

Our hypothesis is that the gully of the Ravine de l'Eglise was formed by successive retrogressive collapses caused by the progressive rise in the groundwater level of the Grand Ilet aquifer. Seven successive model iterations were carried out, gradually increasing the water table level from 15 m above the substratum of the Grand Ilet aquifer to ca. 80 m, corresponding, respectively, to dry conditions and saturated conditions that may have occurred during Cyclone Hyacinthe according to the Gardenia<sup>®</sup> simulation (Figures 6 and 8).

For scenario  $t_0$ , which is characterized by the initial topography of 1978 and a low groundwater level, the slope toe is stable ( $FoS > 1.5$ ), but the upstream talus corresponding to scarp A-A' is unstable to conditionally unstable ( $1 < FoS < 1.2$ ). By increasing the groundwater level by a factor of 2, as has been known to occur in the wet season, a failure takes place downstream from the watershed of the Ravine de l'Eglise and induces a headward retreat of the slope toe of about 100 m (scenario  $t_1$ ). The stability of scarp A-A' remains unchanged. With the same groundwater level, the front of the remaining topography of 1984 is unstable ( $FoS \ll 1$ ). These conditions cause the gully to retreat by ca. 150 m (scenario  $t_2$ ). Pursuing the next simulations in this way, with a piezometric level similar to that simulated for the first ten days of Cyclone Hyacinthe, we observe a succession of more or less large retrogressive destabilizations of the slope. The last scenario corresponds to the saturation of almost all of the intermediate unit, as has occurred during the last days of the Cyclone Hyacinthe rainstorm (scenario  $t_6$ ) [8,42–45]. For this scenario, we observe that the remaining slope is unstable ( $FoS \ll 1$ ) and causes a failure that reaches the current gully head. In these conditions, the post-failure topography is conditionally unstable up to 500 m down the remaining unstable head scarp ( $FoS = 1.12$ ).
