Conceptual model of fracture-limited sea cliff erosion: Erosion of the seaward tilted flyschs of Socoa, Basque Country, France

Mélody Prémaillon, Thomas Dewez, Vincent Regard, Nicholas Rosser,
Sébastien Carretier, Lucie Guillen

Keywords : Sea cliff, erosion, plucking, SfM, photogrammetry, discontinuities, Basque Country, flysch

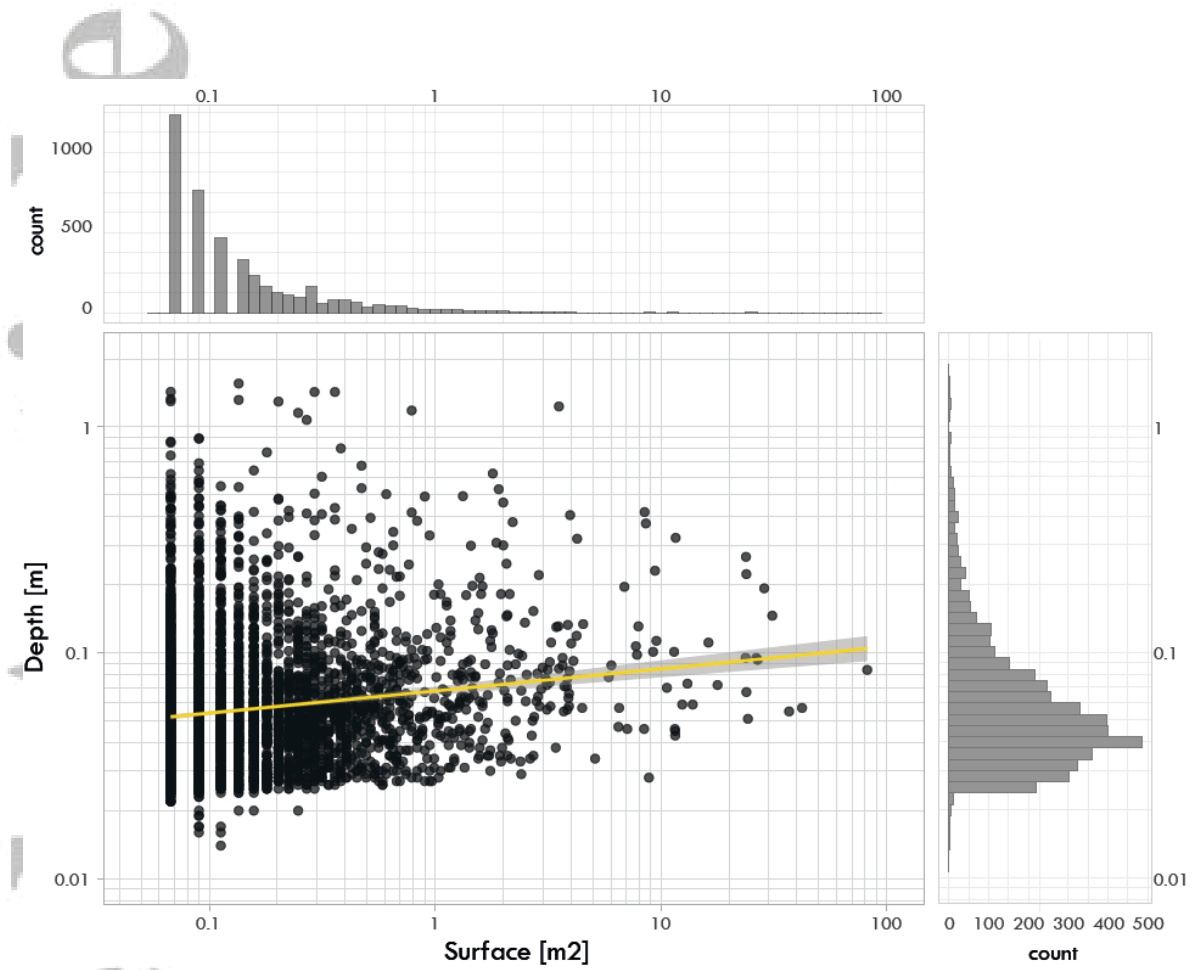
Figure 9: Rockfall scar surface area versus scar depth at the Socoa cliff between 2011 and 2017. Best fit regression line is in yellow, with confidence envelope. Depth mode is 4 cm.

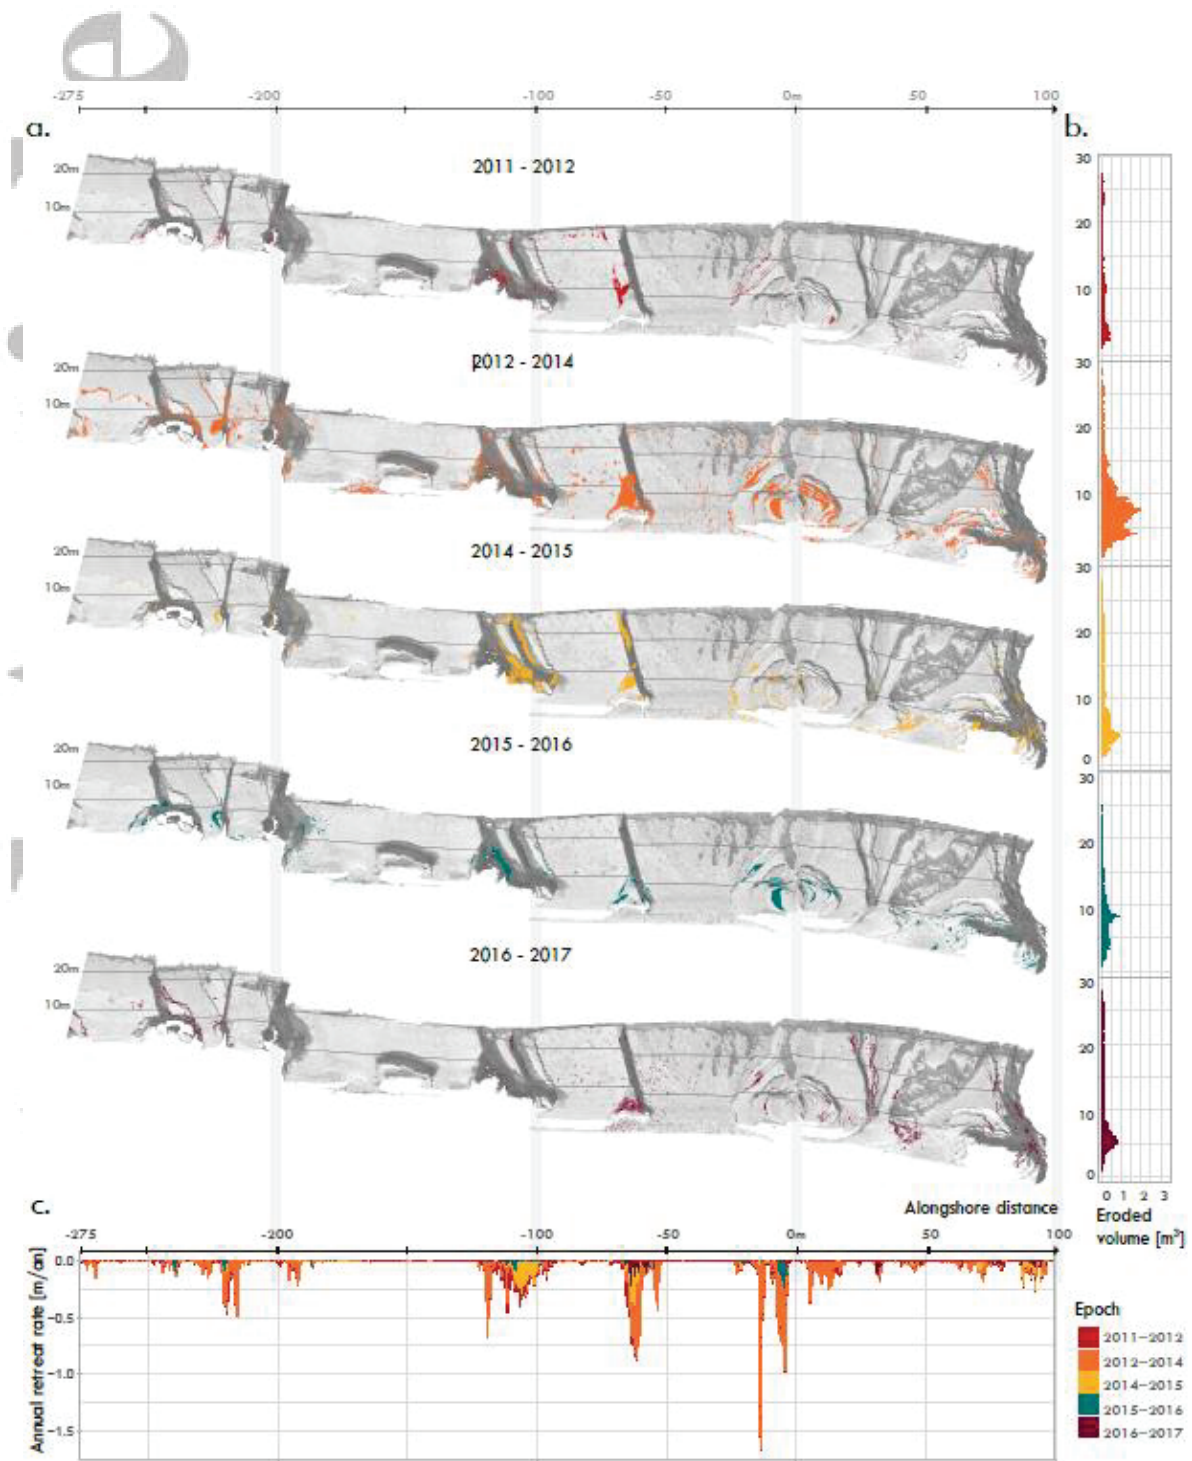
Figure 11: Erosion of Socoa cliff between 2011 and 2017, result of SfM survey. a. colored eroded blocs among cliff face, b. Eroded volume [m^3] vs cliff height, c. Alongshore annual retreat rate [m/yr].

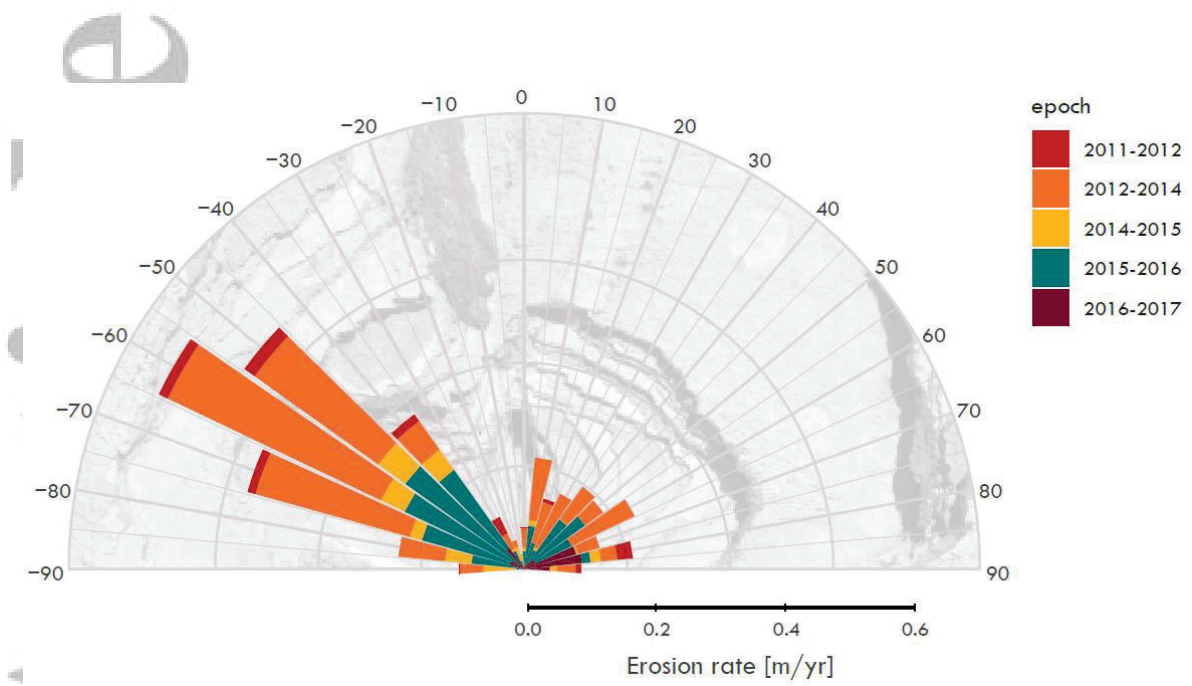
Figure 13: Lateral erosion of concavity #5. Erosion rate is computed every 10 degrees around concavity center. It is represented on a background greyscale image of the concavity.

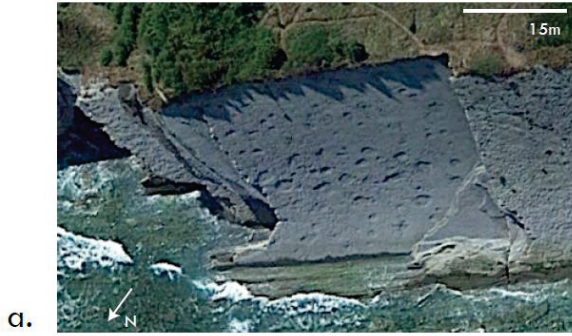
Figure 14: Presentation of elliptical depression erosion phenomenon on a marly strata. A. Google earth view on 2016 where elliptical depressions are well visible; b. Photo from cliff foot and zoom on an elliptical depression; c. Evolution of number of elliptical depressions per year; d. evolution of average elliptical depression's radius.

A second phenomenon of interest has been observed on the surface of turbidite argillaceous marl terms E directly eastward of concavity #4. This slab was first exposed to weathering between February and April 2011 (Figure 14a) when the undercut material slid downslope. (Figure 14a, b). Elliptical depressions started to form and grow outwards on the newly exposed surface. These depressions which etch the slab surface topography result from the detachment of 2-5 cm edge-length polygonal rock flakes or platelets (10^{-2} m, visible in Figure 5 and Figure 14b). Their thickness has a lens-shaped form, typically 3-5 mm at its thickest (10^{-3} m). One particle would weigh 19 grams with approximate dimensions of 3 x 5 x 0.5 cm, and a density of 2.5 g/cm^3 . In cross-section, where this elliptical depression-bearing bed can be observed, the fracturing pattern already exists. It is therefore not a fracture
