Conceptual model of fracture-limited sea cliff erosion: Erosion of the seaward tilted flyschs of Socoa, Basque Country, France

Mélody Prémaillon, Thomas Dewez, Vincent Regard, Nicholas Rosser,
Sébastien Carretier, Lucie Guillen

Running title: Erosion patterns of sea cliffs observed through a 5.7-year Sfm study

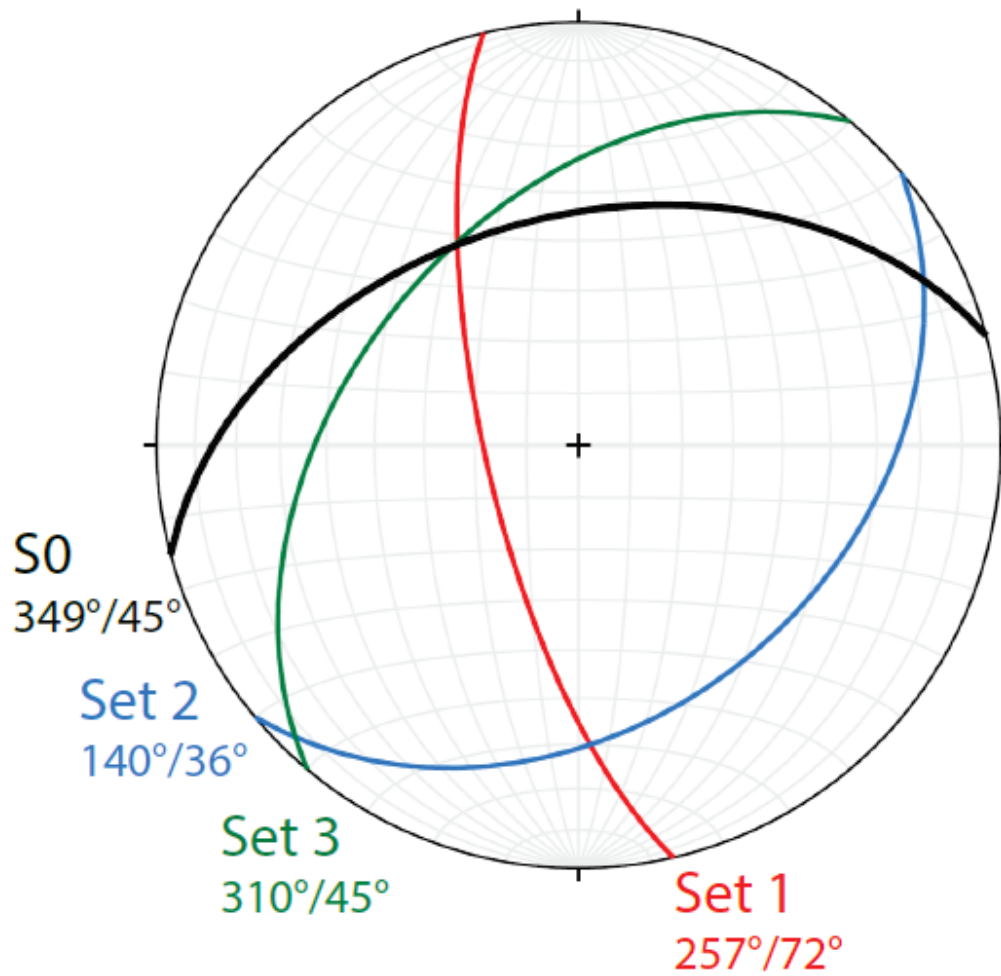
Figure 3: Stereograph of the orientation (dip direction/plunge) of the three sets of faults observed and stratification (S0).
