Muon tomography, seismic noise survey and multi-scale topographic monitoring to assess rockfall hazard at the Maido Rampart (La Réunion Island)

Benoit Le Moigne, Catherine Truffert, Simon Bouteille, Clara Lévy, Jacques Marteau, et al.. Muon tomography, seismic noise survey and multi-scale topographic monitoring to assess rockfall hazard at the Maido Rampart (La Réunion Island). 14th International Symposium on Landslides, CFMR (French Society for Rock Mechanics), Jul 2024, Chambéry (73), France. hal-04627072

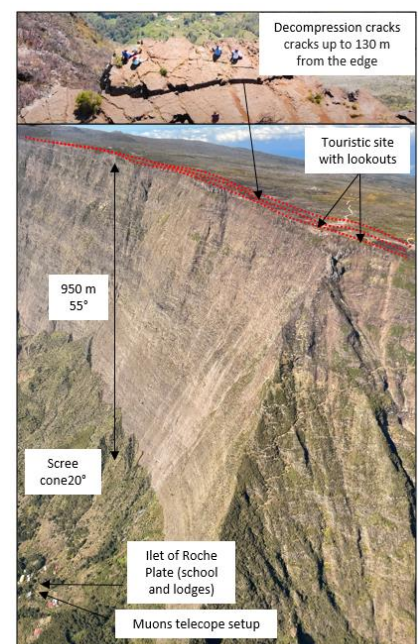
Figure 1: Maïdo rampart configuration

At the Maïdo rampart (figure 1), the fracture network was mapped on the surface using orthophoto and LIDAR data, revealing an extension of cracks over tens of meters, with openings up to several meters. The complexity of the fracture network and its large extent (50,000m²) make difficult the assessment of rockfall hazard. In order to prevent possible rock collapses at this very exposed site, it is therefore necessary to better understand the geometry of instabilities (particularly at depth) and the kinematics leading to rupture.

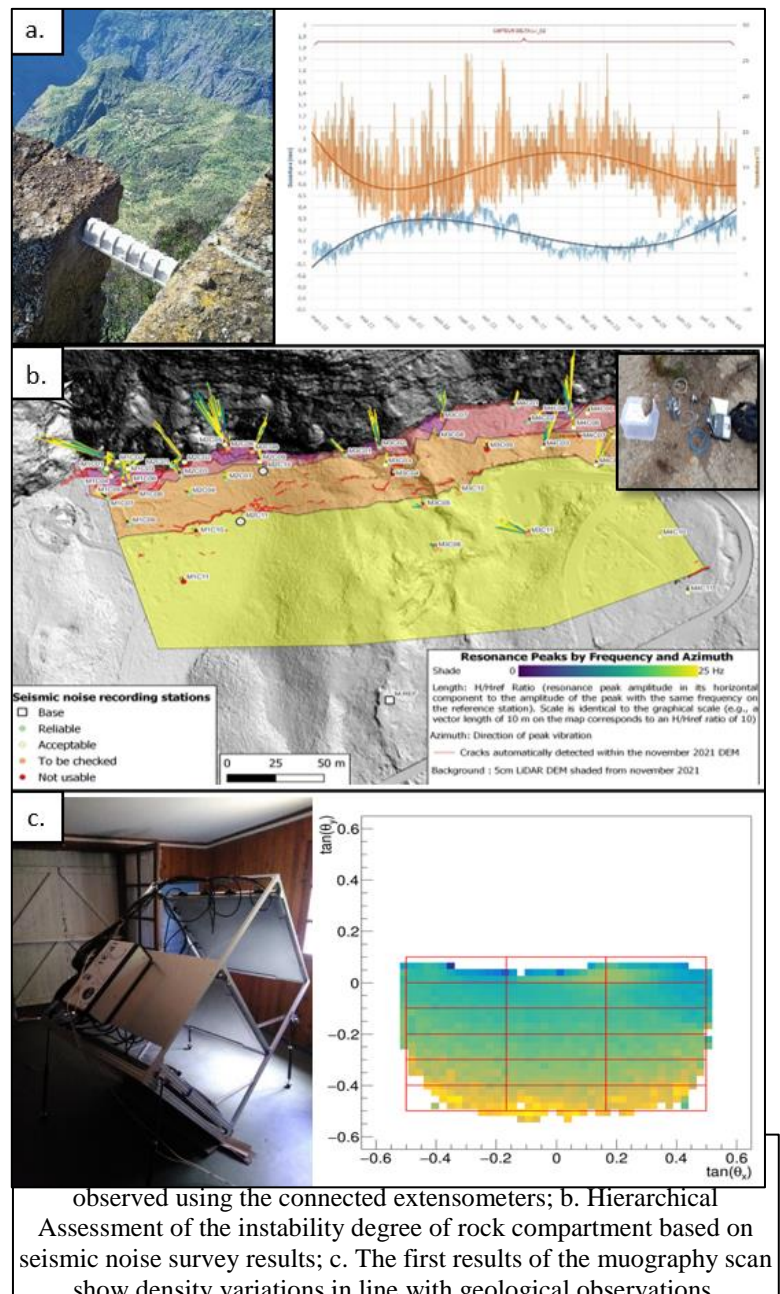
observed using the connected extensometers; b. Hierarchical Assessment of the instability degree of rock compartment based on seismic noise survey results; c. The first results of the muography scan show density variations in line with geological observations.

- A geodetic reference system covering an area of 50,000 m², with semi-annual measurements of 22 control points using a total station, achieving sub-centimeter precision.
- Continuous monitoring equipment, including 12 extensometers (figure 2a) and an inclinometer with measurements taken every 4h, along with 40 displacement gauges. Additionally, an inclinometer was placed on the fissures delineating unstable compartments at the cliff's edge.
- 4 photogrammetric surveys conducted on the upper cliff near the tourist area to track erosion in rocky compartments at the cliff's edge, potentially linked to collapse triggers. The diachronic analysis of these data, only evidenced very small scattered rockfalls, with a maximum volume of 20 m³, located outside of the area of interest.

13 sensors, located near the edge of the rampart, have an average amplification ratio relative to the reference station greater than 5 in the horizontal direction perpendicular to the rampart on the frequency band [0.5 24] Hz (figure 2b). These observations are also consistent with those of Burjanek et al. (2012) which showed that the relative amplification between the reference

Preliminary results indicate observable lithological differences, particularly the presence of thick basaltic flows (figure 3c). Nonlinear density variations with depth hold promise for estimating the depths of
