Study of collapse occurred during the reinforcement work of a vault in a chalk quarry located in the north of Paris (France)

Ahmed Hosni, Baptiste Meire, Gildas Noury, Didier Pennequin

ABSTRACT: A vault of around ten tons weight collapsed unexpectedly during the reinforcement operations carried out in an old underground chalk quarry, which causes a serious accident. This paper describes the accident circumstances, gives some explanations for the accident, and present a simple 3 dimensional model realized to study the stability of the vault taking into account influence of local discontinuities.

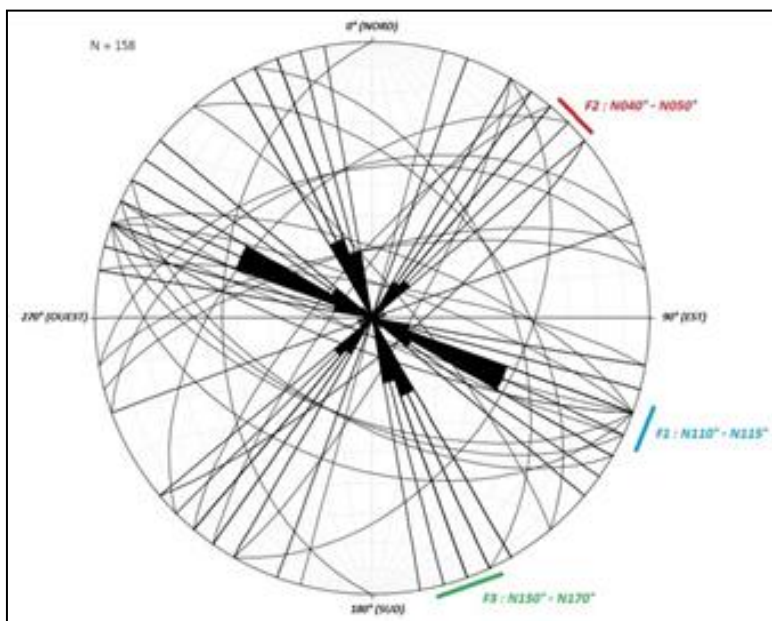
The projection on a Schmidt diagrams (bottom hemisphere) of the 158 observed natural fractures (faults or diaclases), highlights three main orientations (three family) which are consistent with the regional ones (Fig. 5).

- Family F1: with a mean orientation between N110 ° and N115 °. This fracture family is essentially represented by diaclases predominantly vertical or steeply dipping (greater than 75 °). This is a regional orientation, which is found in particular on the chalky cliffs of the coastal coast of the Caux country.
- Family F2: with a mean orientation between N040 ° and N050°. This fracture family is essentially represented by predominantly vertical or steeply diaclases (> 75 ° or 80 °). This is a regional orientation, orthogonal to the previous one (F1).
- Family F3: fracture family only represented by vertical diaclases, which follows a regional orientation and in particular those major tectonic accidents inherited from the basement (Armorican orientation).

Note that the area of the accident is crossed by two diaclases belonging to the F1 family.

Figure 5. Projection on the Schmidt Diagram (south hemisphere) of the three family fractures observed in the chalk studied quarry.
