Soluble salt sources in medieval porous limestone sculptures: A multi-isotope (N, O, S) approach

Soluble salt sources in medieval porous limestone sculptures: A multi-isotope (N, O, S) approach.

W. Kloppmann^a*, O. Rolland^b, E. Proust^a, A.T. Montech^a

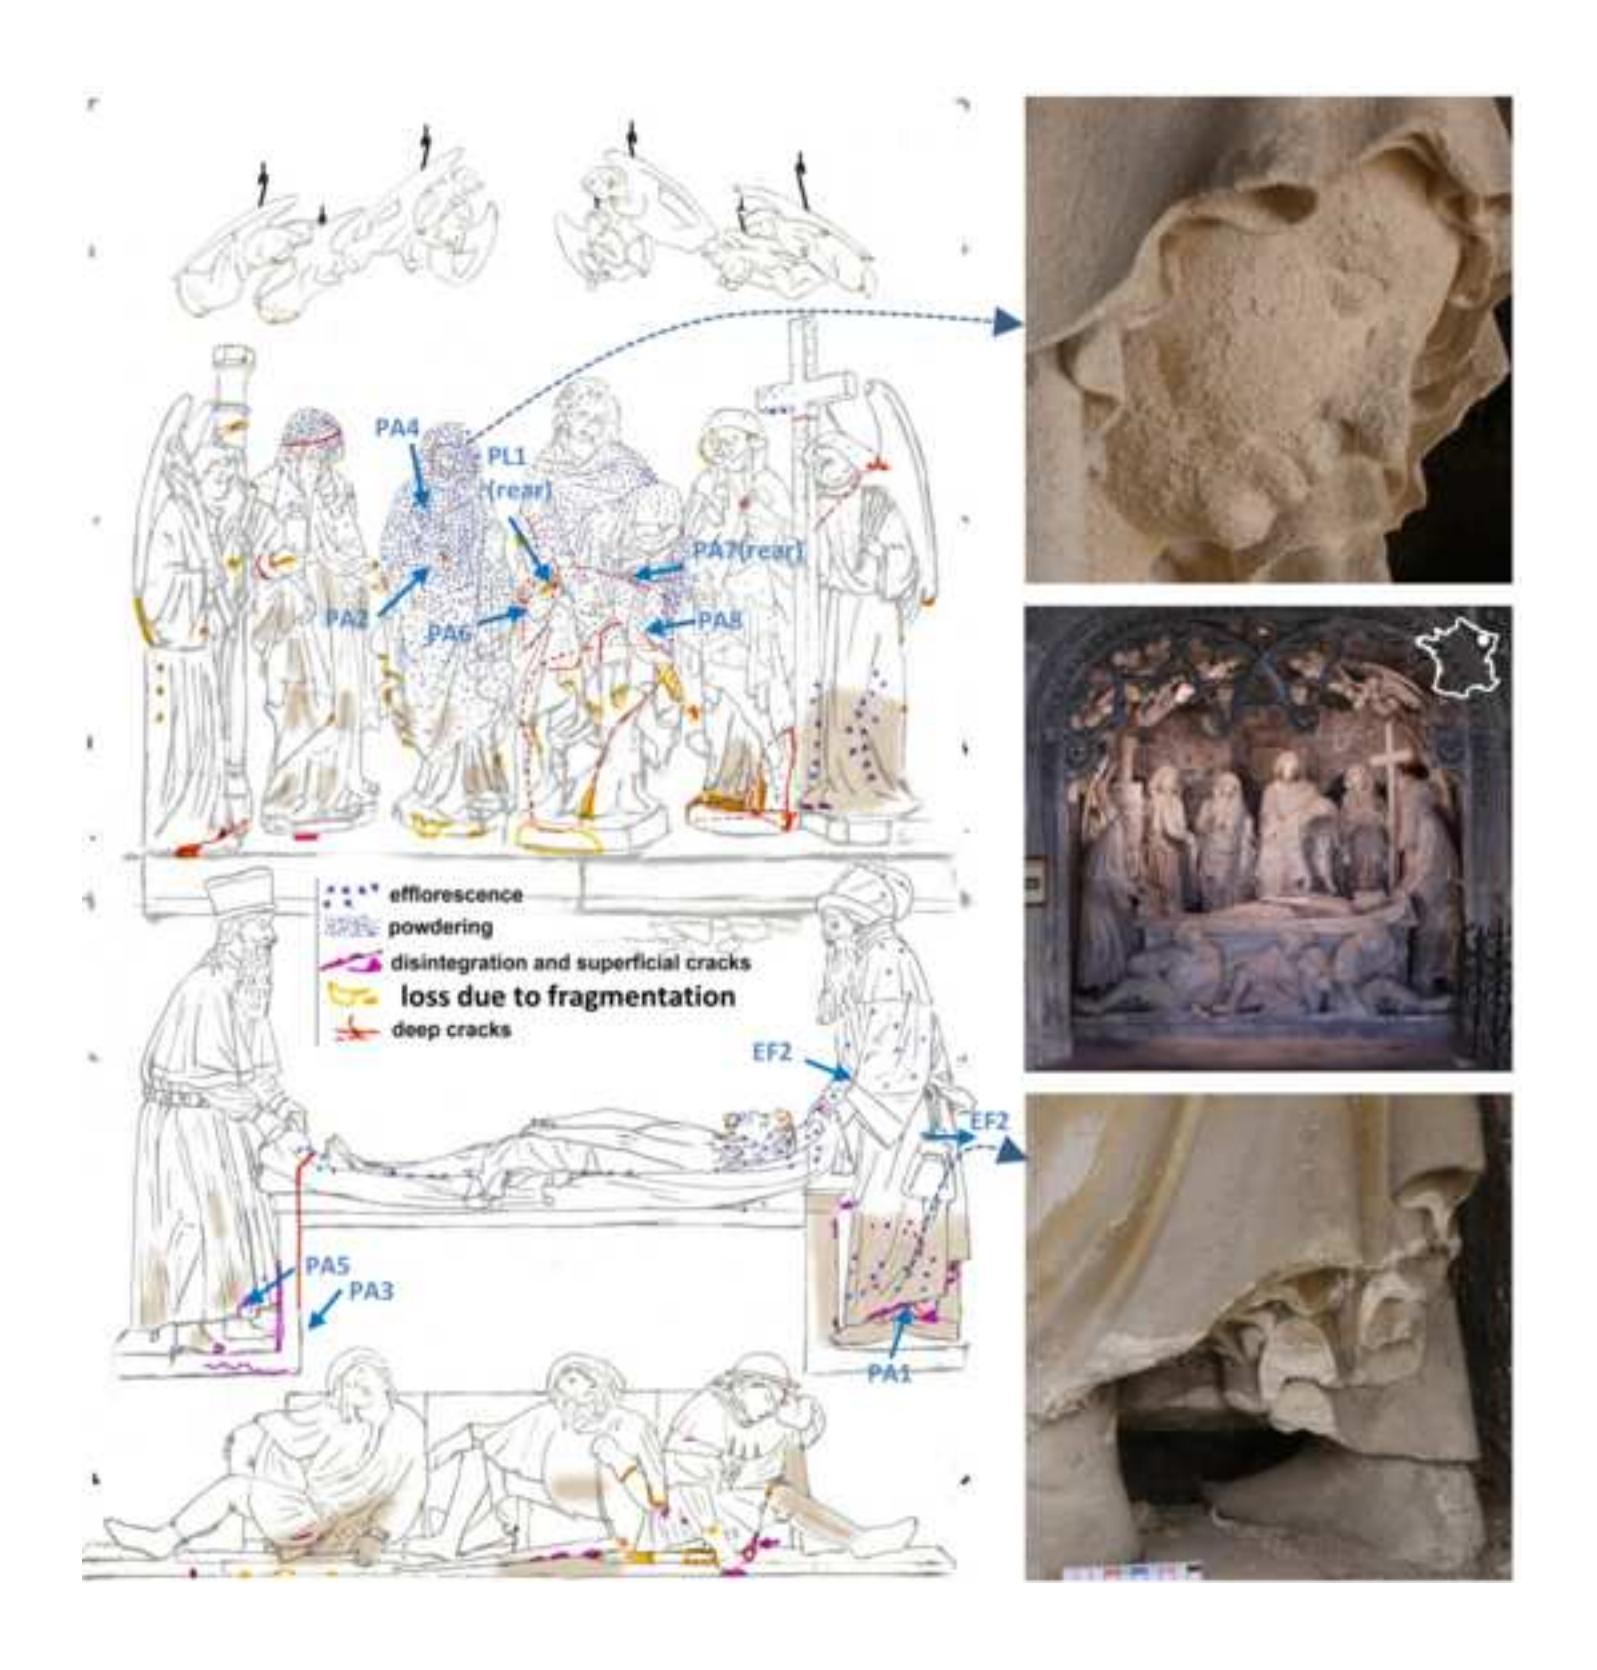
Figure 1: Mapping of alteration types and superficial deposits (modified after Rolland, 2012). The brown patches are places where the surface of the sculpture is covered with a brownish natural patina. Examples of the two main degradation features are provided with powdering (above) and disintegration (below). Arrows indicate sampling points for isotope analyses (rear= rear surface of the statue)

The original material of the sculptures is a fine-grained limestone; some recent replacements are made of oolithic limestone (summit of the cross, elbow of the second female saint). Several reparations and replacements made use of gypsum plaster. The monument has alterations of different types (ICOMOS, 2008): disintegration and superficial cracks, powdering in the higher parts, efflorescences (chemical precipitates), and fragmentation (Figure 1).

Sampling was limited to the surface of the degraded parts of the limestone, by superficial scraping of the disintegrated parts and brushing of the disintegrated powdering parts and of efflorescences (Figure 1). A grab sample of River water was taken on June 17, 2011 on the

Spatial patterns of soluble salt concentrations as well as the identified alteration types vary in function of height (Figure 1). Close to the base of the statues, stones are disintegrated but not powdering; they are rich in sulphates and calcium, pointing to gypsum as main mineral, but low in nitrates and chlorides. In the higher parts, the sculptures are disintegrated and powdering, rich in chlorides, nitrates, sodium, and potassium. Chlorides represent a good tracer of Moselle water and of the accompanying alluvial groundwater as it can be expected that atmospheric inputs are not a significant source of chloride in a continental context. Regional rainwater has in fact chloride concentrations < 3 mg/L in the studied zone (Blum *et al.*, 2002). The influence of river water/groundwater is perceptible for all sampling points but concentrations of chlorides and nitrates are higher in the upper parts of the statues. Less soluble salts (calcium sulphates) precipitate first during capillary rise whereas more soluble salts (nitrates and chlorides) stay mobile and crystallise later, leading to the formation of efflorescence and powdering. Such a zonation has been reported for stone monuments concerned by capillary rise (Arnold, 2004)

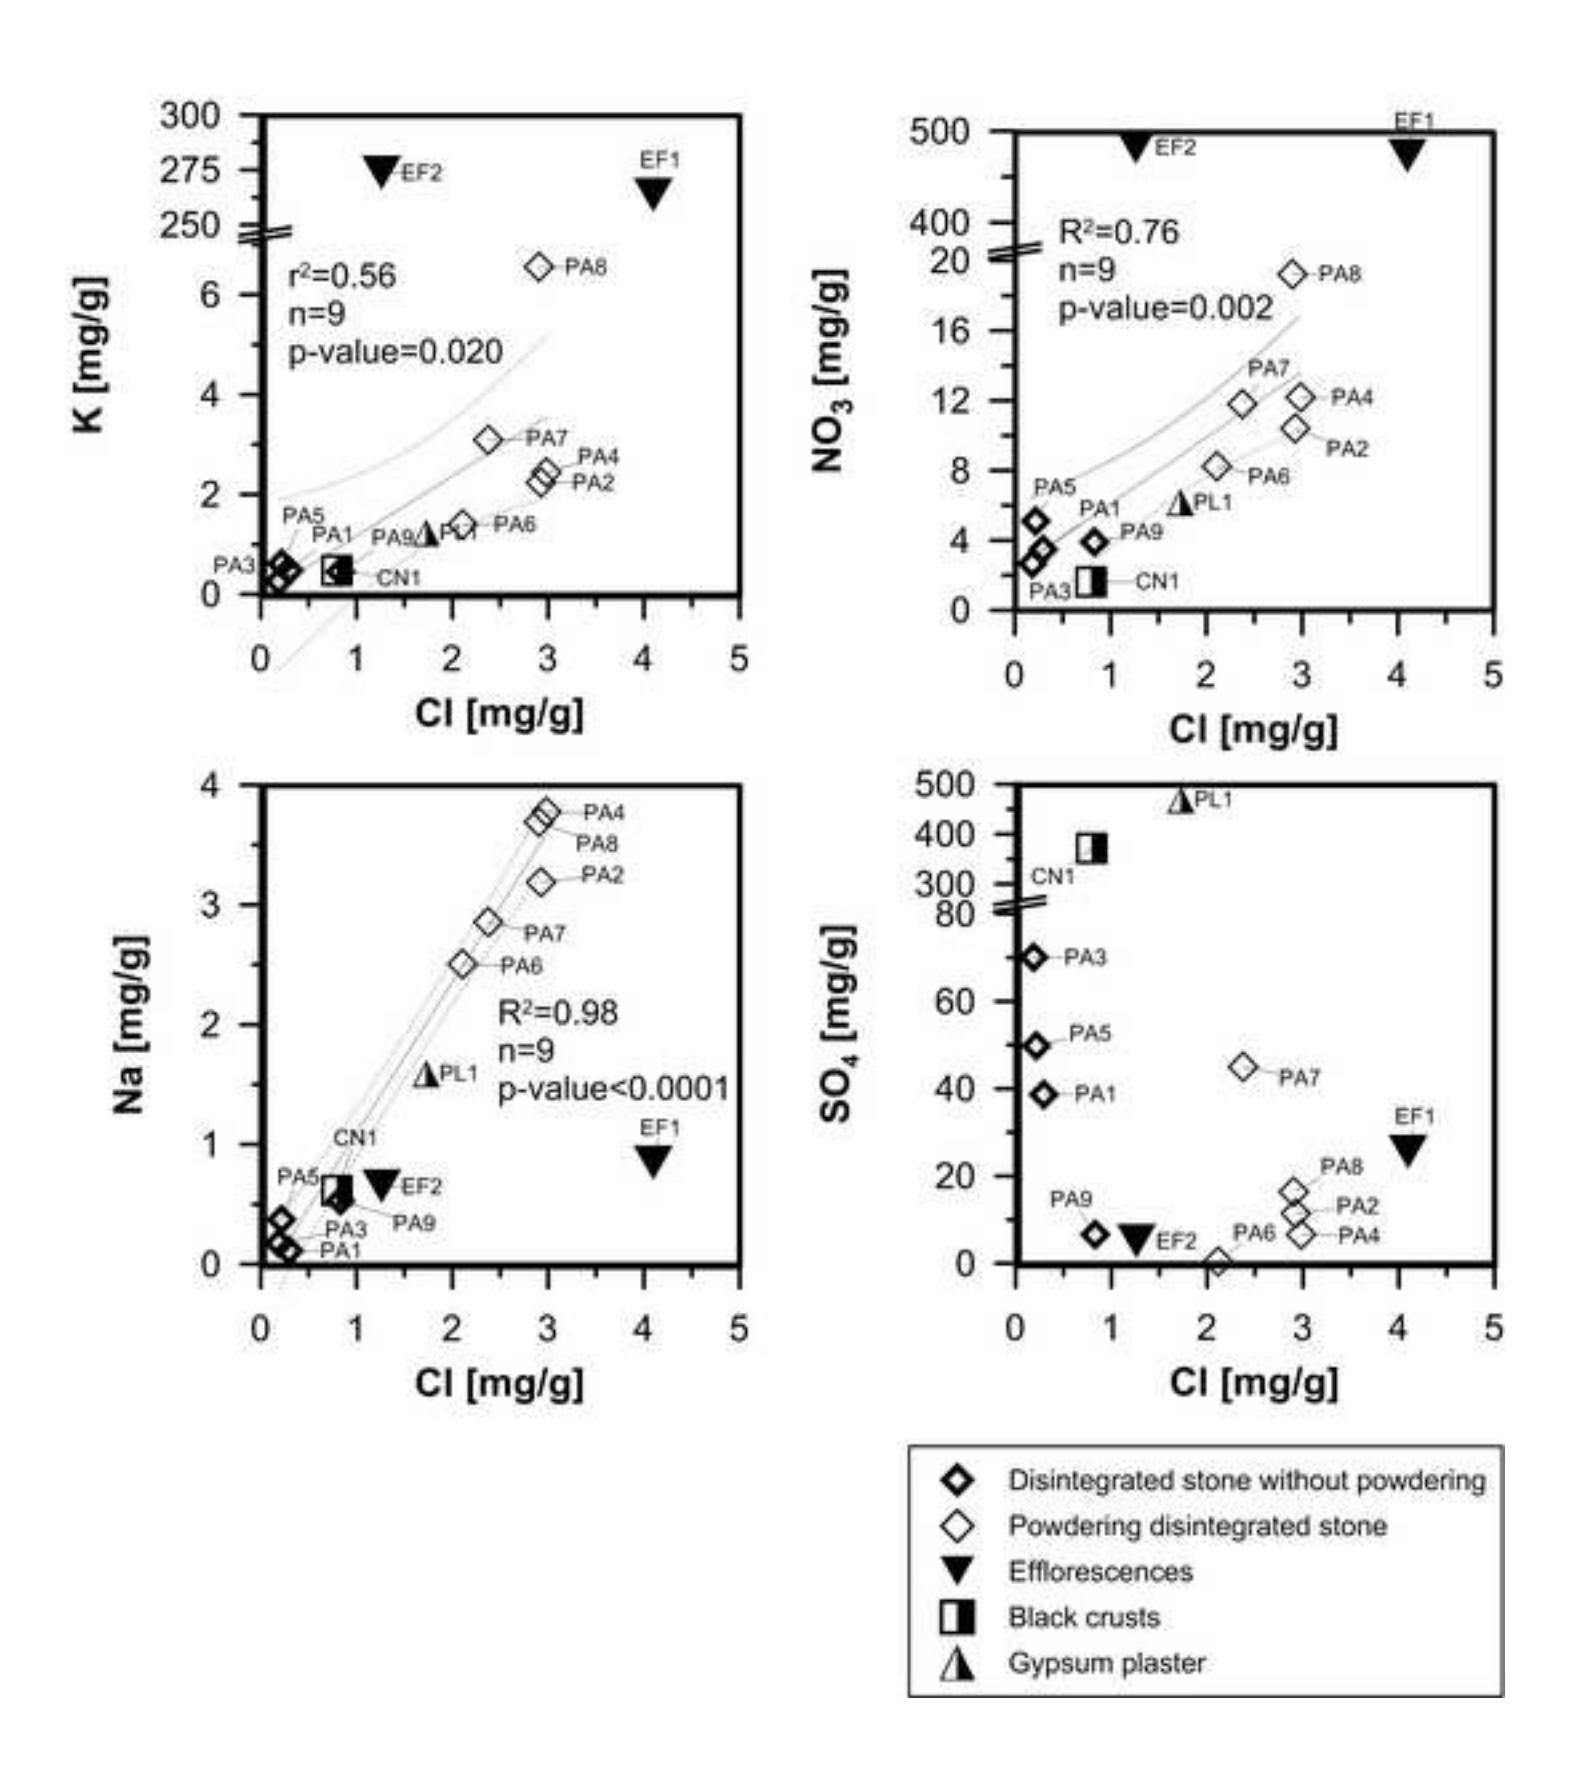
and chlorides (25 mg/g and 4 mg/g respectively, Figure 2). Both the black crust CN1 and the plaster of Paris PL1 contained more than 50% calcium sulphate;

Major ions (Table 2, providing solid/solid concentrations of the leachable fraction of the total rock), with exception of bivalent cations (Ca, Mg) and bicarbonates, which are related to the mineralogical nature of the limestone used for the group of sculptures, discriminate several types of alteration. Disintegrated stones without powdering (PA1, 3, 5) from the base of the statues are rich in sulphates (concentrations higher than 40 mg/g) but poor in Na, K, NO₃, and Cl. Powdering stones from the upper parts of the statues are rather low in sulphates, with exception of sample PA7, but contain significant amounts of K, Na, NO₃⁻, and Cl which are more or less correlated (Figure 2). Efflorescences are mainly KNO₃ with negligible concentrations of other elements so that they plot outside the tendencies observed for the altered stone samples. Sample EF1 is somewhat richer compared to sample EF2 in sulphates

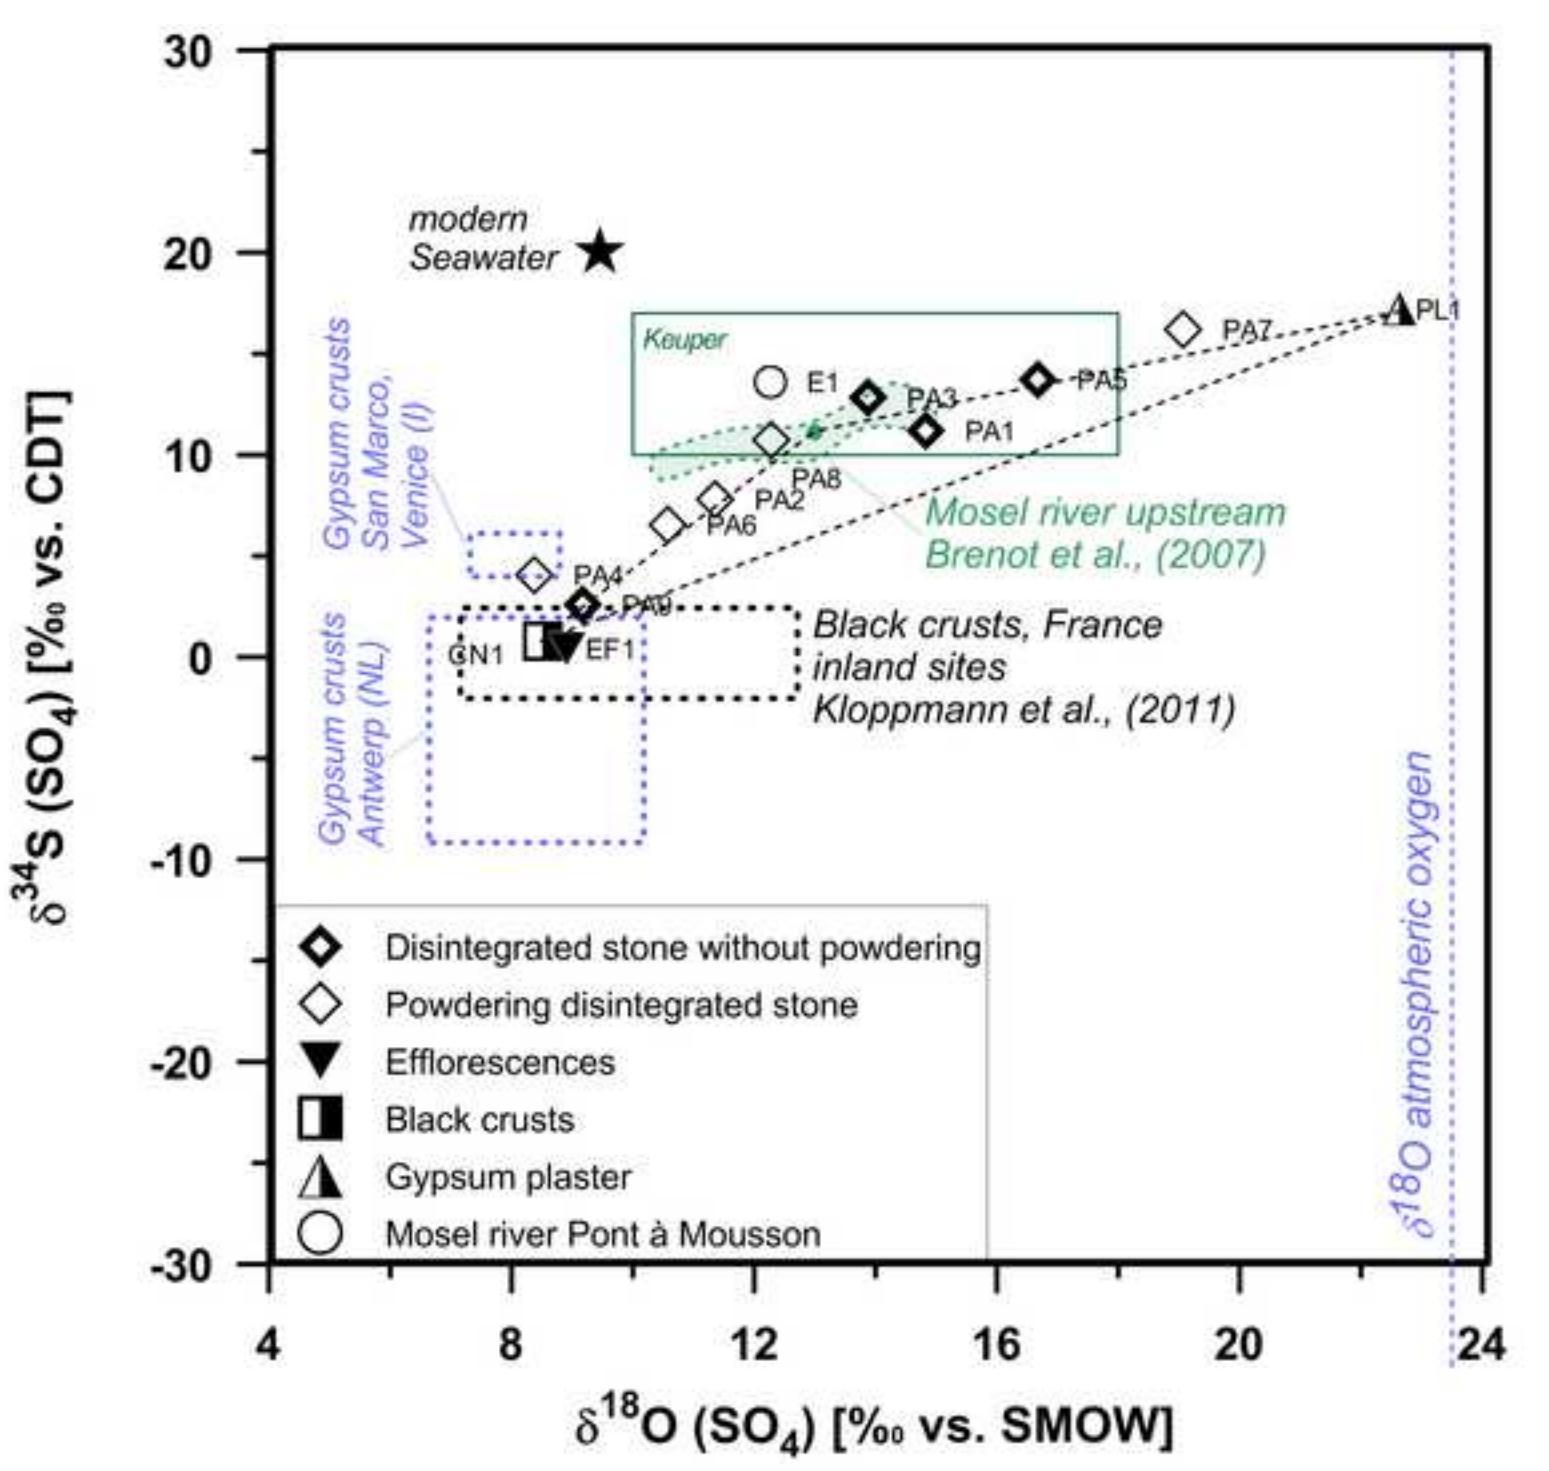
relatively narrow range typical for air pollution-derived black crusts measured on other French monuments out of the coastal zone potentially influenced by sea salts (Bourges and Chartres cathedrals, Chenonceau and Versailles castles, Kloppmann *et al.*, 2011) (Figure 3).

All stone samples fall clearly off a mixing line for δ^{18} O and δ^{34} S of the atmospheric and the plaster endmember. We observe two mixing trends requiring a third endmember which is compatible with mean Moselle water at Messein and Pont-St-Vincent (δ^{34} S = 11.1 ‰ and δ^{18} O =13 ‰). Nevertheless, the approximate co-linearity of the three end members makes it difficult to quantify their respective contributions (Figure 3). The disintegrated stone samples close to the base of the statues (PA1, 3, 5) fall in the field of Keuper gypsum, confirming the influence of groundwater through capillary rise (Figure 3). Samples of powdering stone taken

The sulphates which constituted the major part of the black crust CN1 (37% of sulphate or 67% of gypsum), sampled on the external wall of the southern facade are considered as representative of local air pollution as the sampling location was potentially out of reach of capillary rise and no gypsum plaster was used in the surroundings. Their isotopic composition with a δ^{34} S of 0.8 ‰ vs. CDT and a δ^{18} O of 8.5 ‰ vs. SMOW falling-falls indeed in the

on the upper parts of the statues (PA2, 4, 6, 8) show a good correlation (r²=0.93, n=4, <u>p-</u> value=0.036, statistics performed with XLSTAT software package) in the δ^{34} S vs. δ^{18} O diagram (Figure 3) suggesting mixing between two end members, "Moselle water" and "air pollution" represented respectively by samples E1 and CN1. Sulphates in sample PA4 appear to be nearly exclusively dominated by air pollution. Indoor sulfation of carbonates can be favoured by particulate matter (Grau-Bové and Strlic, 2013), itself containing oxidised sulphur compounds (e.g. for diesel particulate matter) or acting as catalyser of SO₂ fixation, and gypsum formation (Rogriguez-Navarro and Sebastian, 1996, Cultrone et al., 2008). It needs to be stated, though, that this group of powdering stone samples is rather poor in sulphates (0.4 to 16 mg/g). The powdering sample PA7 presents a singularity as it is shifted towards the signature of the plaster sample PL1 and is rich in sulphates (>45 mg/L). It was taken from the back of John (Mary and John are carved in a single bloc; Figure 1 and Supplemental Information Photograph) in the vicinity of the plaster reparation which provided PL1 and may contain plaster-derived sulphates, dissolved by capillary rising groundwater, and then transported by diffusion in the interstitial porosity of the fine-grained limestone.

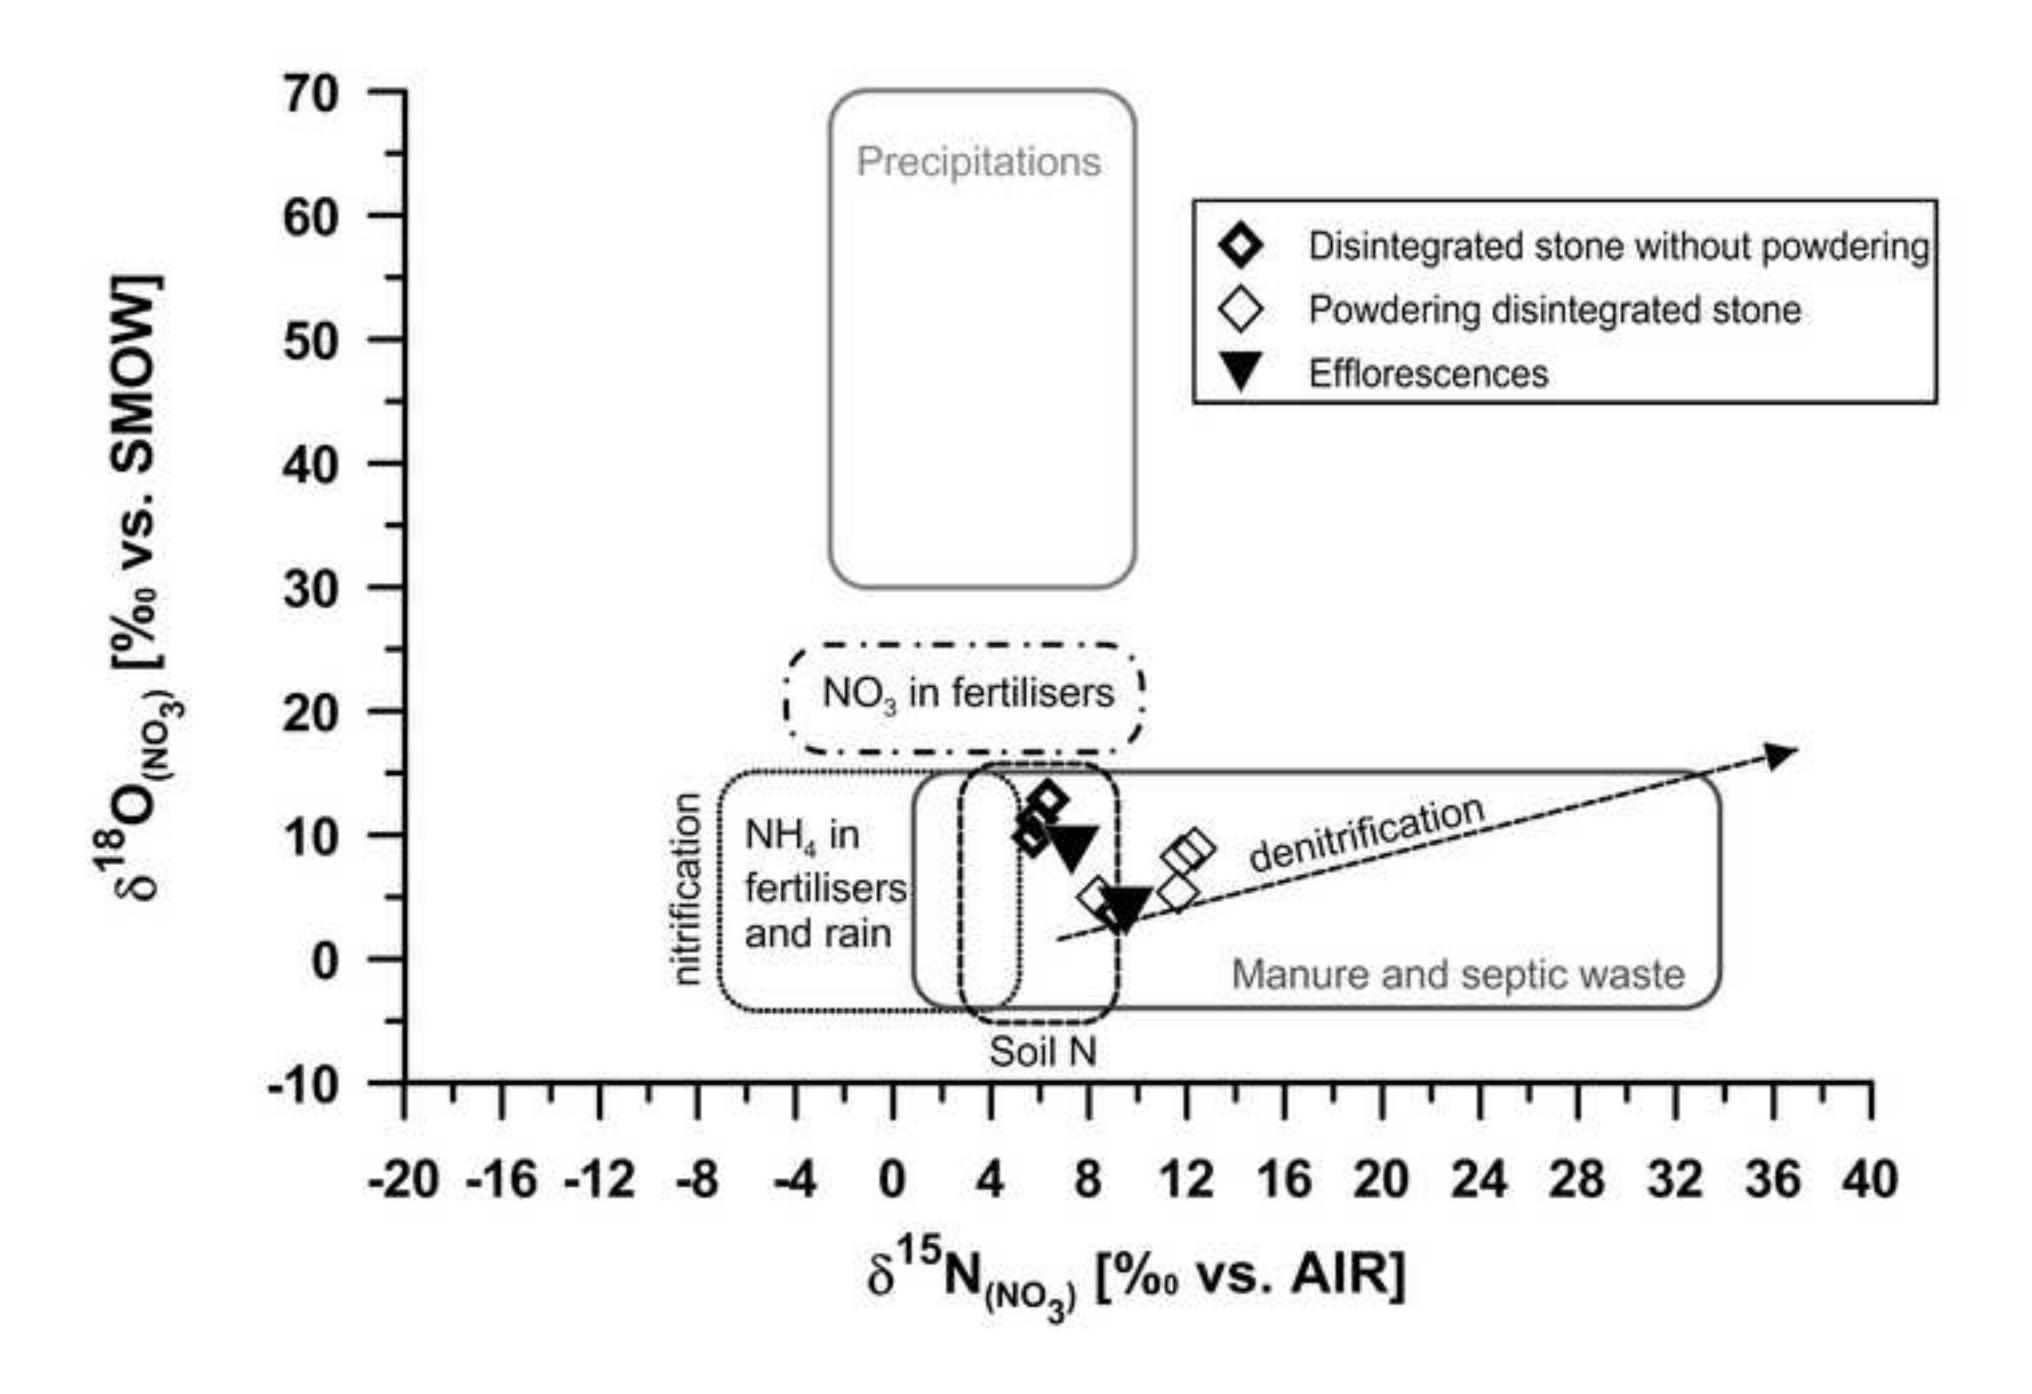
Nitrates from all altered stone samples as well as the K-nitrate efflorescences fall in the field of animal waste (Figure 4, Kendall *et al.*, 2007) and are comparable to the signatures measured in the alluvial aquifer of the Moselle river further downstream. The nitrate contents of the altered stones seems therefore to stem from human faeces or animal waste, either via local sewage input or diffuse agricultural pollution of the riverine water by manure spreading in the upstream parts of the catchment. The fact that the measured Moselle water is richer in Na than in K is not incompatible with the preferential formation of nitre (KNO₃) in the efflorescences as solubility of nitre is by a factor of 2 (at 20°C) to 4 (at 0°C) lower than that of nitratine (NaNO₃) so that nitre will form first (Laue, 2005).

The isotope signatures of nitrates (Table 2) differentiate two groups of disintegrated stone samples at the base of the statues (PA1, 3, 5) fall in a restricted range of δ^{15} N values from 5.7 to 6.3 %. The signatures of the most nitrate-rich alluvial groundwaters at Yutz (Widory and Nguyen-Thé, 2006) are compatible with those measured at the lower part of the statues. The efflorescences EF1 and EF2 as well as sample PA9, sampled at the external wall of the church within the potential zone of capillary rise, show a δ^{15} N somewhat enriched in ¹⁵N ranging from 7.3 to 9.5 ‰ (Figure 4).The disintegrated powdering stone samples from the upper part of the statues (PA2, 4, 8) form a well-defined group with a δ^{15} N between 11.6 and 12.3 ‰and δ^{18} O between 5.4 and 8.9 ‰. Since measured $\delta^{18}O_{(NO3)}$ values are incompatible with an atmospheric origin of nitrates as they are much to low compared with the range of air pollution derived NO₃ (Elliot *et al.*, 2009) this indicates that the predominant agents of air pollution in the sector were SO_x which is compatible with contamination from smelters.
